# Alexandra Park and St Helen's Road, Hastings Cycle Route Review

Document Ref: SCH009-RP-0001

East Sussex County Council

December 2017

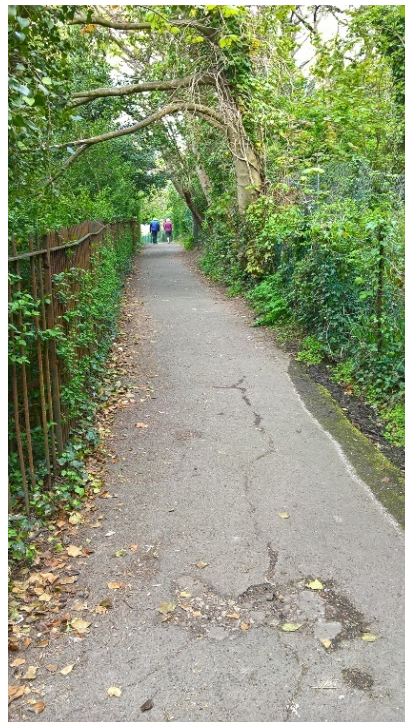
The width of the path measures between 2.5m and 2.7m with a 6' high chain-link fence on the northern side and a 1.2m high metal palisade fence on the southern side. Each vertical bar in the palisade fence is topped with a blunt, rusty, point. To be compliant with design standards this path should be 4m wide (3.0m effective width with 0.5m 'buffer zones either side). There is no scope to widen the path to achieve this without acquiring additional land from either the Park or private property. The narrow width increases the risk of conflict with other users and cyclists clipping the adjacent fence lines and losing control.

*The following image shows the existing path*

The gradient of the path is steep over its entire length. There is the risk of high cycle speeds when heading downhill towards the Park and loss of control / collision with other users. The problem is compounded at the top end of the slope which serves as a vehicular access to an adjacent private residence, with the obvious conflict issues.

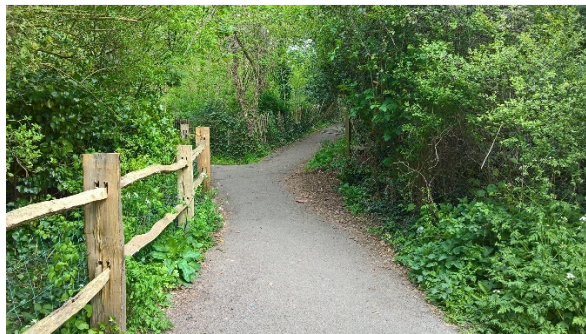
*The following image highlights the poor visibility and the footpath link.*

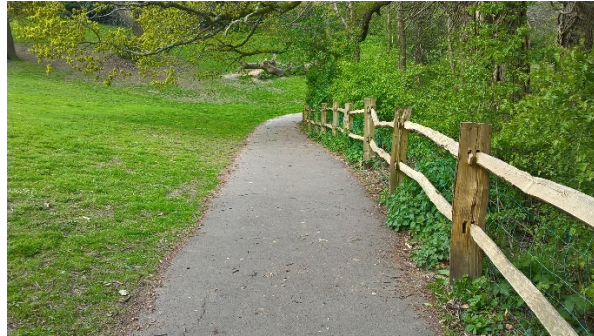
*The following image highlights the poor visibility looking westwards.*

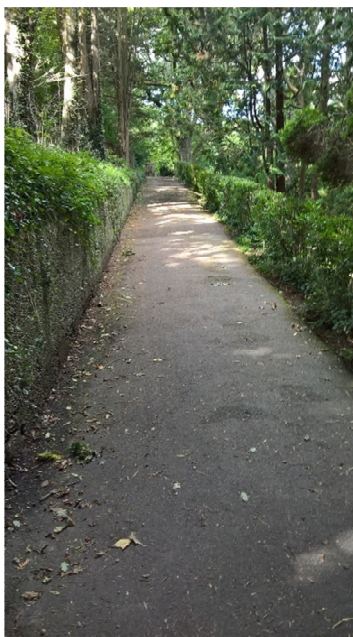
The ramp measures approximately 2.5m in width with a retaining wall along one side and a timber rail fencing along the other side, but increasing the width of the ramp to the required 4m would need land within the Park to be re-designated. The ramp is on a fairly steep gradient and there are concerns that cyclists would gain speed on entering the Park, increasing the potential for loss of control and collision with other non-motorised users. The existing timber post and rail fence bounding the northern side of this ramp currently measures 1.2m high and may need to be replaced with a 1.4m high fence.

*The following image shows the existing access path.*

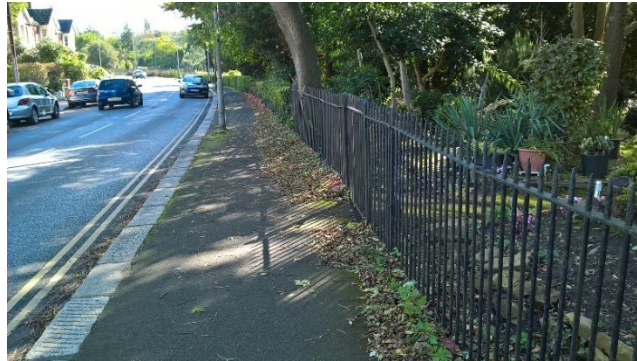
The back of the footway is bounded by the standard park metal palisade fence and a short section of low hedging. For most of its length the fence measures in excess of 1.4m in height but there is a length of approximately 75m where the height is reduced to approximately 1.1m. This poses a significant risk of injury to an errant cyclist and would therefore require replacing with a higher fence. The section of hedging measures approximately 80m in length and is approximately 900mm high.

*The following image looks eastwards along St Helen's Road  
Note the low metal fence (1.1m high) and distant hedge boundary.*

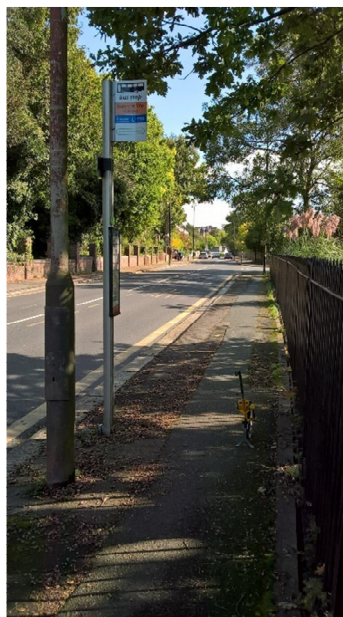
Immediately west of its junction with Dordrecht Way is a bus stop. This introduces an additional element of conflict between cyclists and passengers waiting for a bus. Patronage has been obtained from Stagecoach who indicate that approximately 50 passengers board and alight at this stop each day.

At these conflict points the width of the footway should, ideally, be increased to 4.0m to minimise the potential for conflict with passengers waiting for a bus. In this location the footway measures approximately 2.3m and the adjacent carriageway approximately 7.75m. With the northern footway only measuring approximately 2.4m in width, there is insufficient corridor width available allowing the footway to be sufficiently widened.

*The following image highlights the narrow footway at the bus stop.*

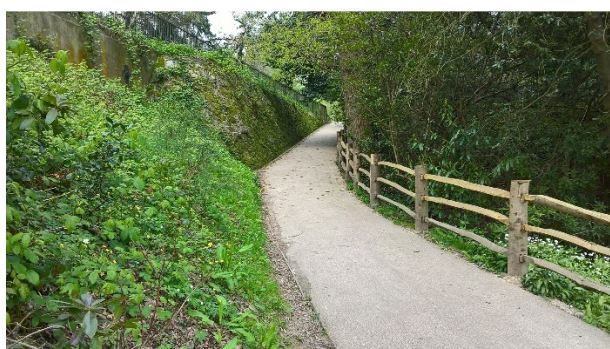
*The following image is of the existing ramped access.*

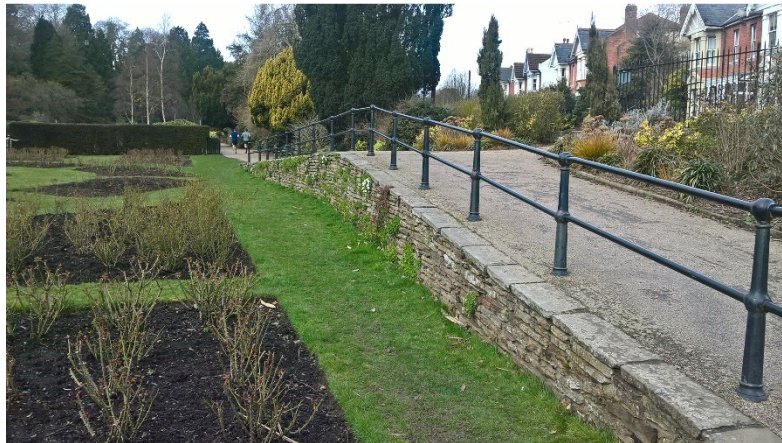
*Elevated path*

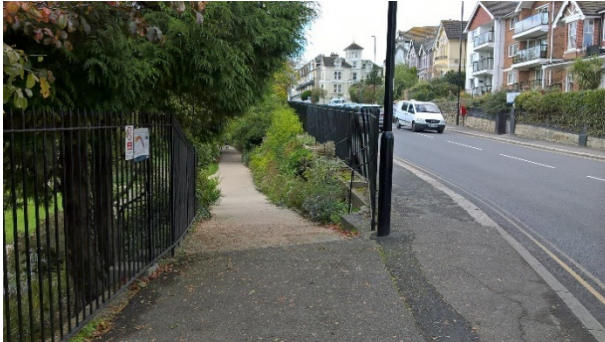
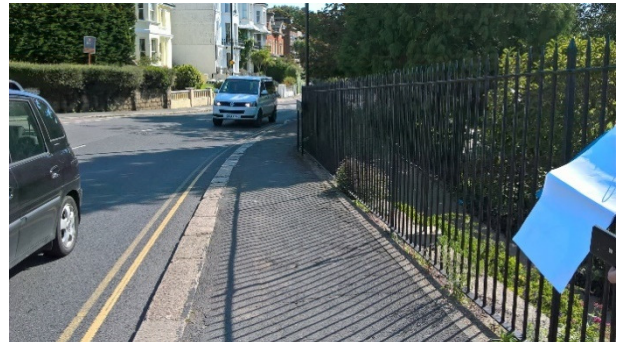
*The following two images show the pinch point.*

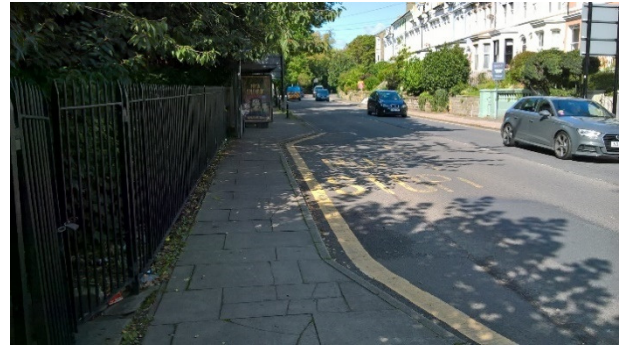
The main issue along this length relates to existing trees that have been planted along the front of the footway. These are creating localised pinch points. There are 13 No. trees planted at regular spacing ranging in size between 200mm and 350mm in diameter. The average clearance between the tree trunk and the boundary fence at the back of the footway currently measures approximately 2.5m, which is 1.5m narrower than the recommended minimum of 4.0m (3.0m effective width with 0.5m 'buffer zones' either side of path). These trees will continue to grow over time, resulting in further reduced effective footway width.

*The following two images show the existing layout.*
