Alexandra Park and St Helen's Road, Hastings Cycle Route Review

Document Ref: SCH009-RP-0001

East Sussex County Council

December 2017

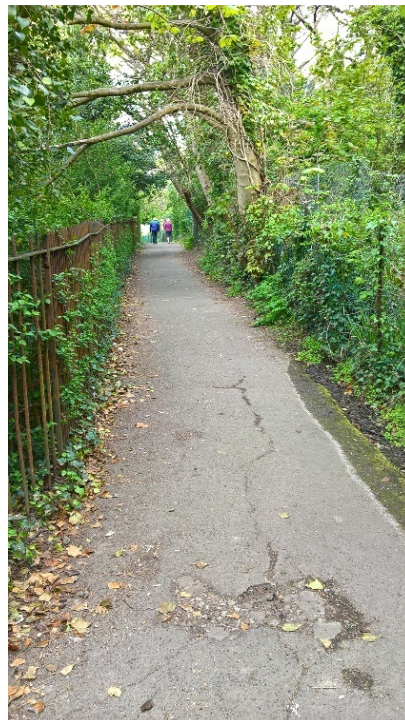
The width of the path measures between 2.5m and 2.7m with a 6' high chain-link fence on the northern side and a 1.2m high metal palisade fence on the southern side. Each vertical bar in the palisade fence is topped with a blunt, rusty, point. To be compliant with design standards this path should be 4m wide (3.0m effective width with 0.5m 'buffer zones either side). There is no scope to widen the path to achieve this without acquiring additional land from either the Park or private property. The narrow width increases the risk of conflict with other users and cyclists clipping the adjacent fence lines and losing control.

The following image shows the existing path

The gradient of the path is steep over its entire length. There is the risk of high cycle speeds when heading downhill towards the Park and loss of control / collision with other users. The problem is compounded at the top end of the slope which serves as a vehicular access to an adjacent private residence, with the obvious conflict issues.

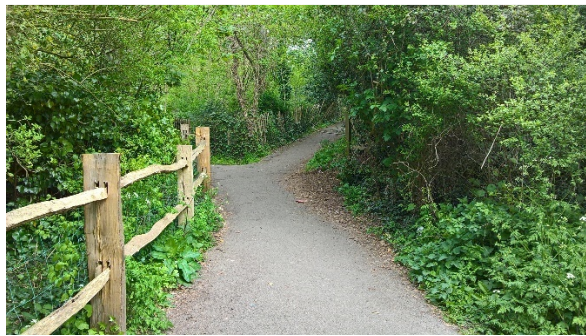
The following image highlights the poor visibility and the footpath link.

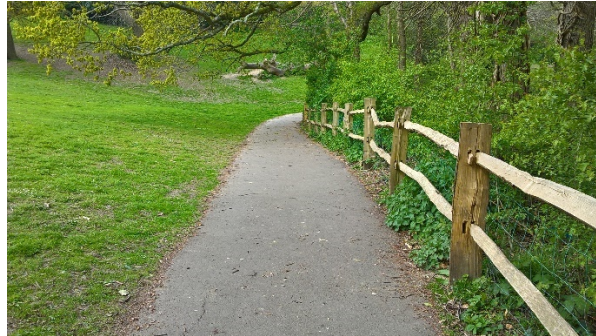
The following image highlights the poor visibility looking westwards.

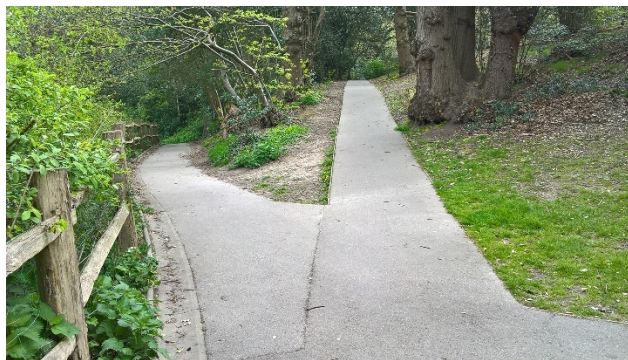
This section of the route passes through an area of fairly dense woodland on an existing, narrow, path that measures approximately 1.5m in width. In order to provide a shared facility that can achieve the minimum recommended effective width of 3.0m, the path would have to be widened by a minimum of 2.0m to provide clearance to mature trees that are growing immediately adjacent to the path. The ground falls away along the northern side, particularly at the western end, and significant earthworks would be necessary to widen the path. It would not be possible to provide an effective width of 3.0m without impacting on the existing trees / shrubs.

The following image is of the narrow path (the right-hand path) through the woodland area, looking eastwards

Despite the above, one area would still remain as having an unacceptably high level of risk, Section I, the narrow path through the woodland. Trees and shrubs alongside this narrow corridor prevent the existing footpath from being widened. Unless it is accepted that mature trees can be removed to accommodate a wider path it is not possible to reduce the level of risk over this section. In view of this it is recommended that an alternative route is considered.

One alternative option, to avoid this section of the route, is to utilise an existing path to the north (as detailed on drawing HGN-SCH0009–DR–CH-0012). For most of its length this alignment provides a 3.0m to 4.0m wide corridor. In the context of the rest of the Park the gradient of this route is generally suitable. For the most part this corridor is an ‘unmade’ track and in its current condition not suitable for cyclists. As shown in the image below.

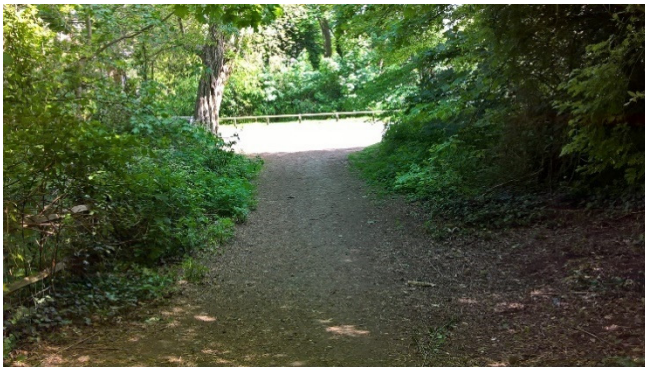
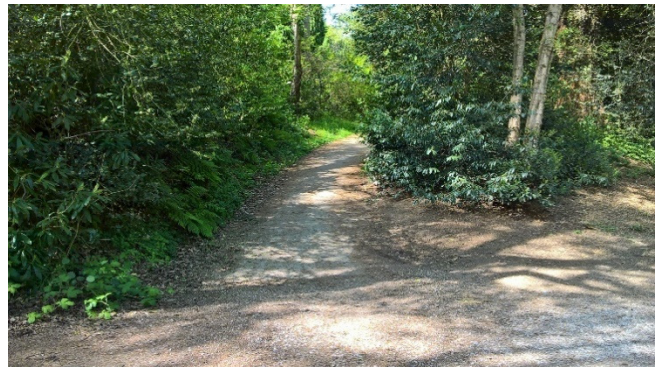
The following images are taken from the path towards the private road and from the private road looking back towards the exit from Section 1.

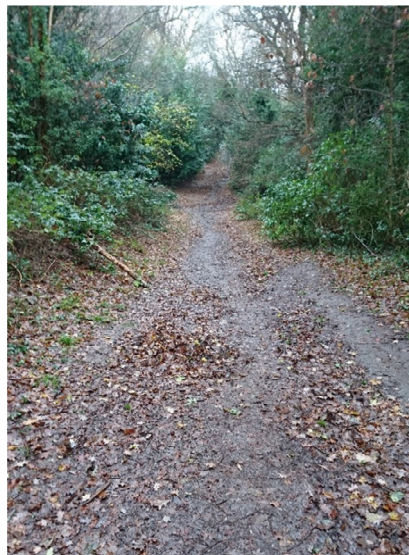
The following image show the existing unmade track.

With this said, there is opportunity, subject to budget and environmental constraints, to construct a new bound surfaced path. The only concern with this option is the initial 60m section. As shown by the image overleaf. The combination of restricted width (only 2.2m) and steep gradient makes this section less conducive to a shared use path. Although there is limited scope to widen the path over the initial 30m, measures may be adopted, such as signing and lining, to encourage slow cycling speeds. With this said the gradient is such that it may discourage users from cycling up this section.

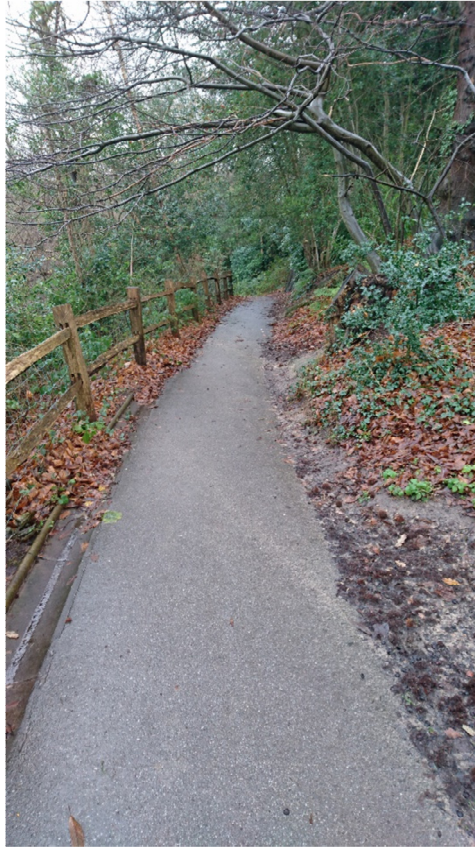
The following image show the initial 30m of alternative path.

Neither Section I or the first 60m of the alternative route can achieve the recommended design parameters for shared use paths, whether this is effective width or gradient. In view of this, either it is accepted that a reduced standard facility can only be achieved, or a scheme that advises cyclists to dismount is promoted. Alternatively, a wider route review to explore further options is undertaken which may lead to route options being considered outside the Park altogether.

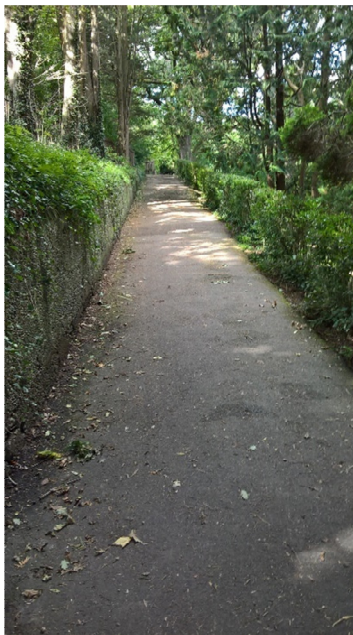
The ramp measures approximately 2.5m in width with a retaining wall along one side and a timber rail fencing along the other side, but increasing the width of the ramp to the required 4m would need land within the Park to be re-designated. The ramp is on a fairly steep gradient and there are concerns that cyclists would gain speed on entering the Park, increasing the potential for loss of control and collision with other non-motorised users. The existing timber post and rail fence bounding the northern side of this ramp currently measures 1.2m high and may need to be replaced with a 1.4m high fence.

The following image shows the existing access path.

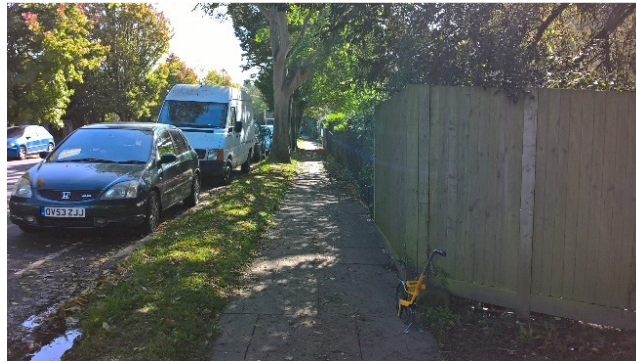
required from the tree and fence. It is recommended that a shared route should have an effective width of 3.0m. To meet this requirement the path between the trees and park boundary fence would need to be 4.0m wide to allow for the necessary clearances.

The following image looks eastwards along St Helen's Road from where cyclists would exit the Park. Note the mature trees in the verge.

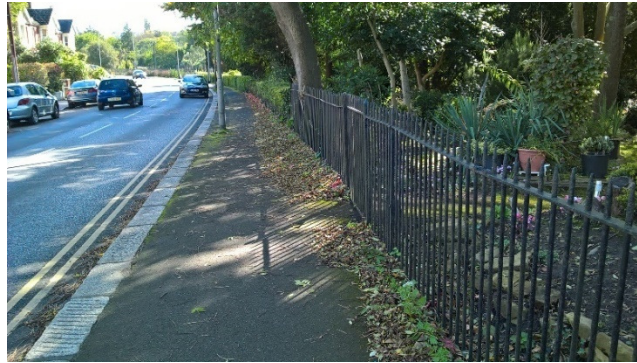
The back of the footway is bounded by the standard park metal palisade fence and a short section of low hedging. For most of its length the fence measures in excess of 1.4m in height but there is a length of approximately 75m where the height is reduced to approximately 1.1m. This poses a significant risk of injury to an errant cyclist and would therefore require replacing with a higher fence. The section of hedging measures approximately 80m in length and is approximately 900mm high.

*The following image looks eastwards along St Helen's Road
Note the low metal fence (1.1m high) and distant hedge boundary.*

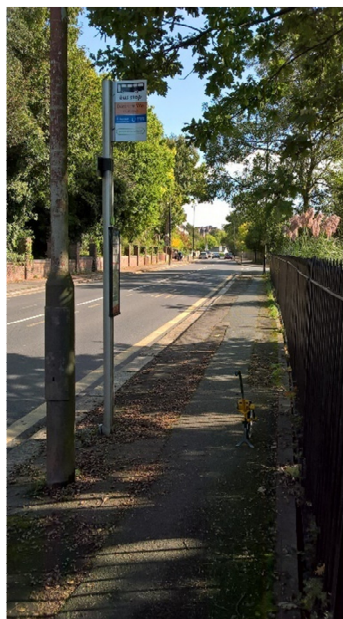
Immediately west of its junction with Dordrecht Way is a bus stop. This introduces an additional element of conflict between cyclists and passengers waiting for a bus. Patronage has been obtained from Stagecoach who indicate that approximately 50 passengers board and alight at this stop each day.

At these conflict points the width of the footway should, ideally, be increased to 4.0m to minimise the potential for conflict with passengers waiting for a bus. In this location the footway measures approximately 2.3m and the adjacent carriageway approximately 7.75m. With the northern footway only measuring approximately 2.4m in width, there is insufficient corridor width available allowing the footway to be sufficiently widened.

The following image highlights the narrow footway at the bus stop.

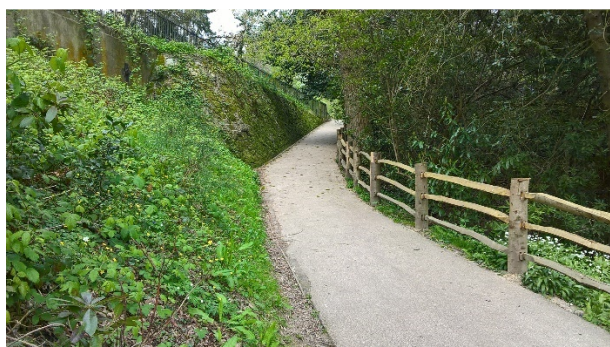
The following image is of the existing ramped access.

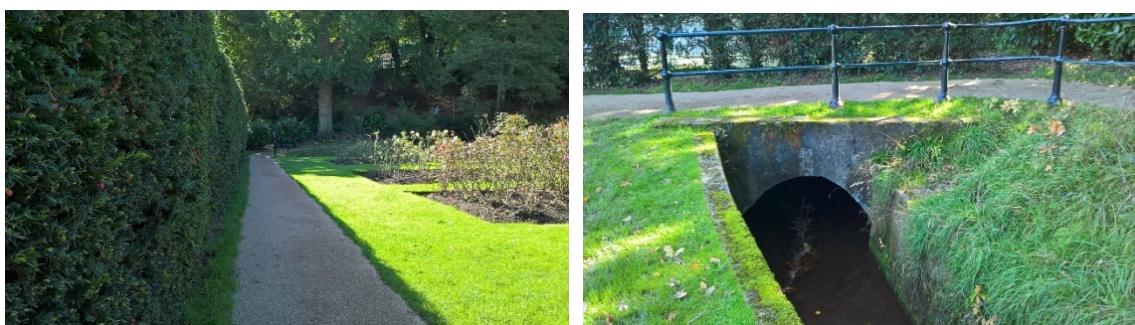
The following images show the existing narrow path and structure.

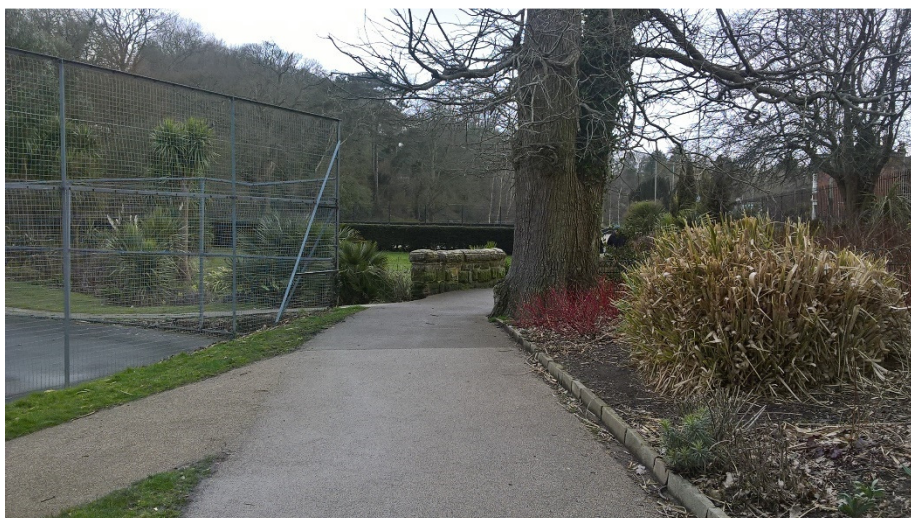
Existing bridge with tree obstructing visibility

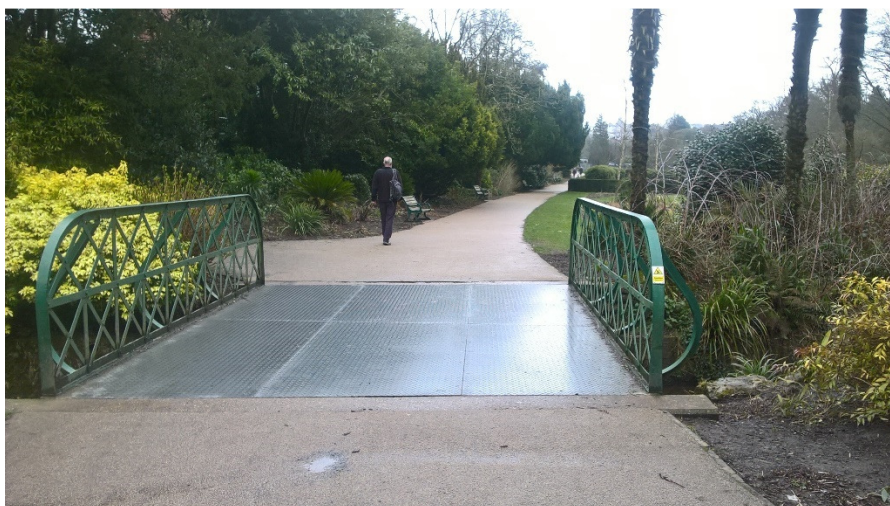
The route would need to pass over an existing bridge crossing a small water course. Although the width of the bridge measures 3.9m, the parapet height is lower than the required standard to facilitate cycle use. The metal surface of the bridge deck could also become slippery in wet conditions.

Existing bridge crossing water course

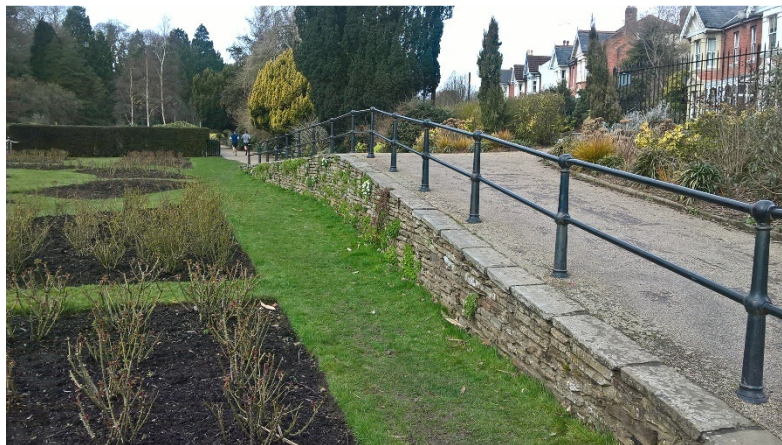
Elevated path

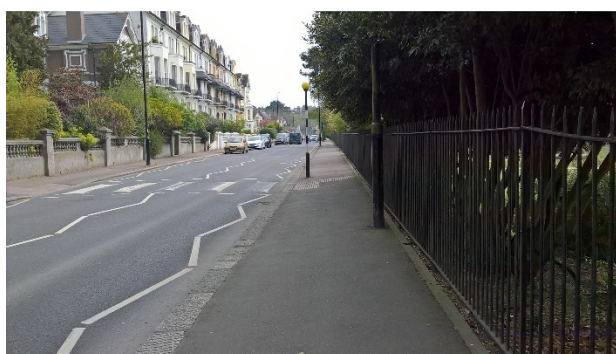
The following image is taken on St Helen's Road looking eastwards towards the zebra crossing.

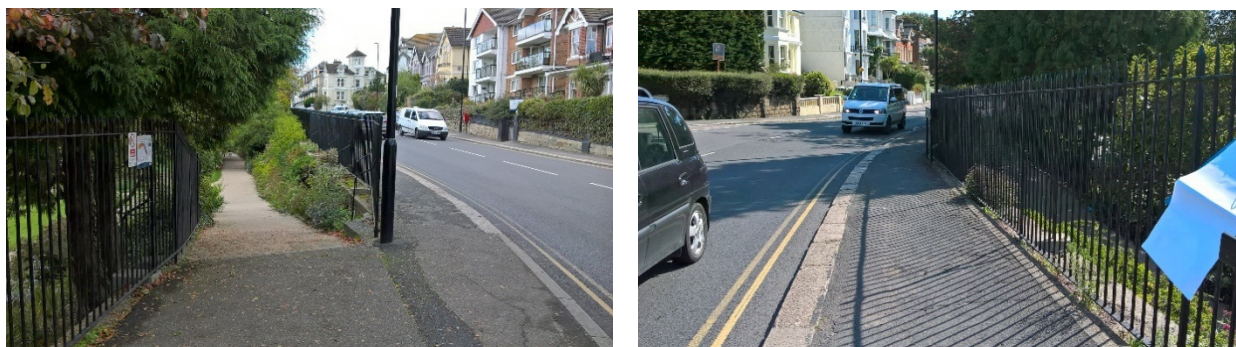
The following two images show the pinch point.

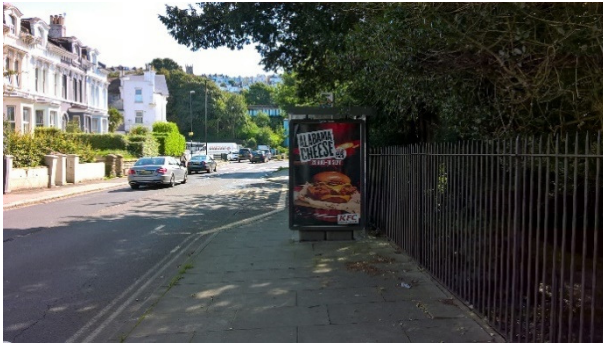
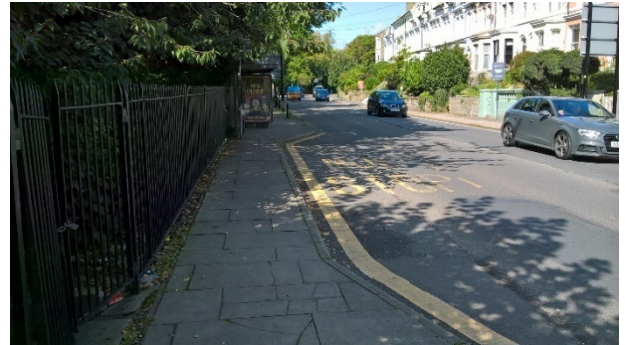
The main issue along this length relates to existing trees that have been planted along the front of the footway. These are creating localised pinch points. There are 13 No. trees planted at regular spacing ranging in size between 200mm and 350mm in diameter. The average clearance between the tree trunk and the boundary fence at the back of the footway currently measures approximately 2.5m, which is 1.5m narrower than the recommended minimum of 4.0m (3.0m effective width with 0.5m 'buffer zones' either side of path). These trees will continue to grow over time, resulting in further reduced effective footway width.

The following two images show the existing layout.

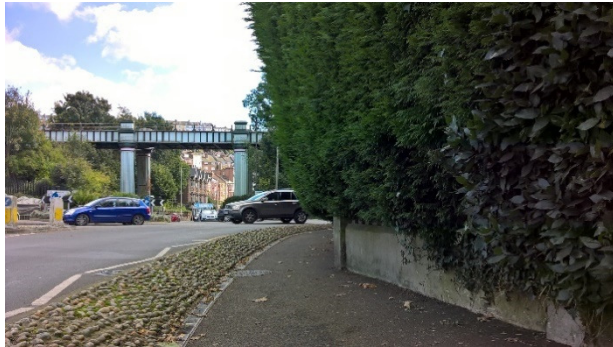
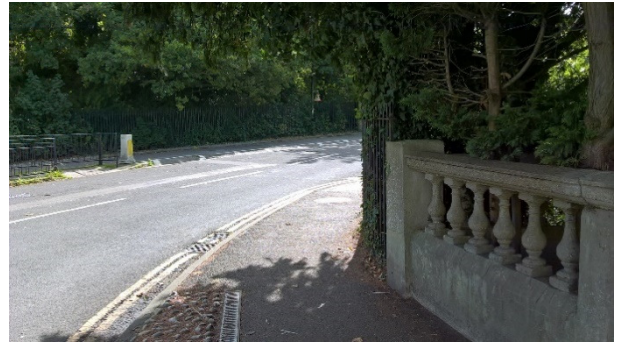
This section is equally as difficult an area to resolve in terms of providing an effective width path of 3.0m, as recommended. This section is on the south-western corner of the roundabout with the footway being at a lower level than the adjacent carriageway. The footway is divided into two strips – a pedestrian deterrent area along the front edge which is used to take up the level difference and the actual footway positioned at the back. The footway measures approximately 1.7m in width. Mature conifer trees are growing immediately behind the adjacent boundary wall and these overhang the footway by some distance. It would be necessary to hard-prune these conifers but this is likely to leave an unsightly boundary as mature conifers do not generally generate new growth where hard-pruning has taken place.

The following images show the existing layout.

Through Sections K and L widening of the existing footway into the carriageway would result in significant changes to the roundabout, particularly given the level difference between the footway and carriageway. The alternative option would be to widen along the back edge of the footway by removal of the mature evergreen trees and re-aligning the boundary wall. However, it has already been established that removal of the existing park boundary is not permitted. Bearing in mind the difficulties in achieving this final section of the route it is recommended the cycle route is terminated in advance of the existing zebra crossing with cyclist re-joining the carriageway.

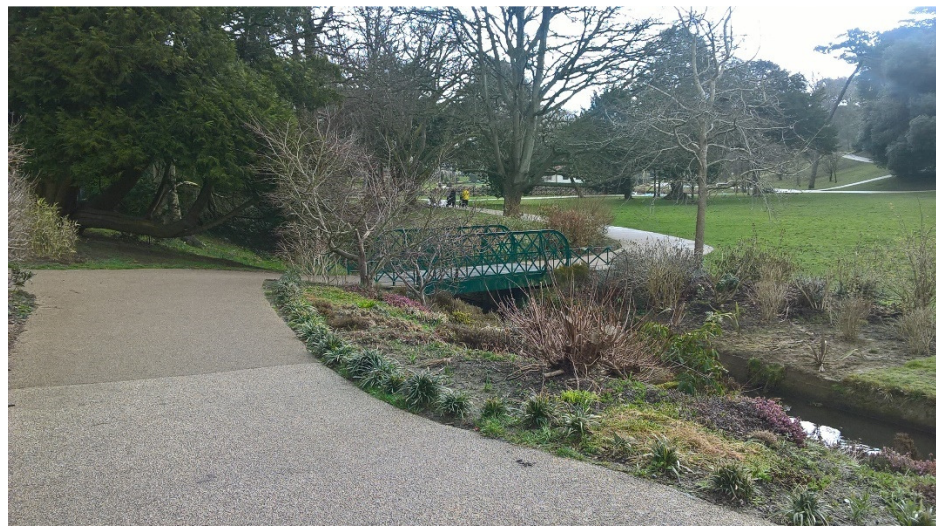
Option 4 Section C: Sharp corner, downhill gradient approaching water feature.

With regards to Option 4, a similar approach would be taken as to the types of improvements recommended to raise awareness to all users of the shared route. Where space permits path widening to a minimum of 3.0m would be recommended in order to provide a suitable facility for shared use. With this said there are still sections along this route where improvement measures would not be possible, such as Sections C,D, and F and the risks would remain high.

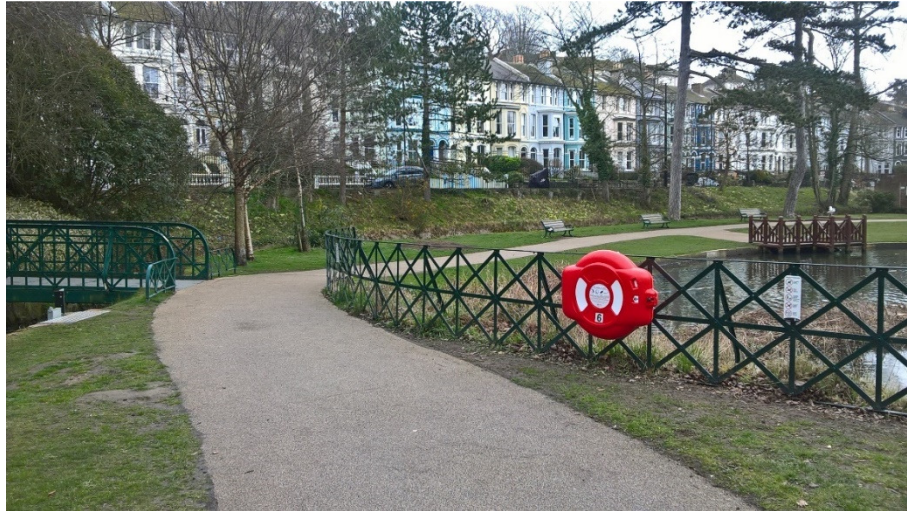
Option 4 Section D: Sharp corner, limited width to widen path to increase clearance to water feature.

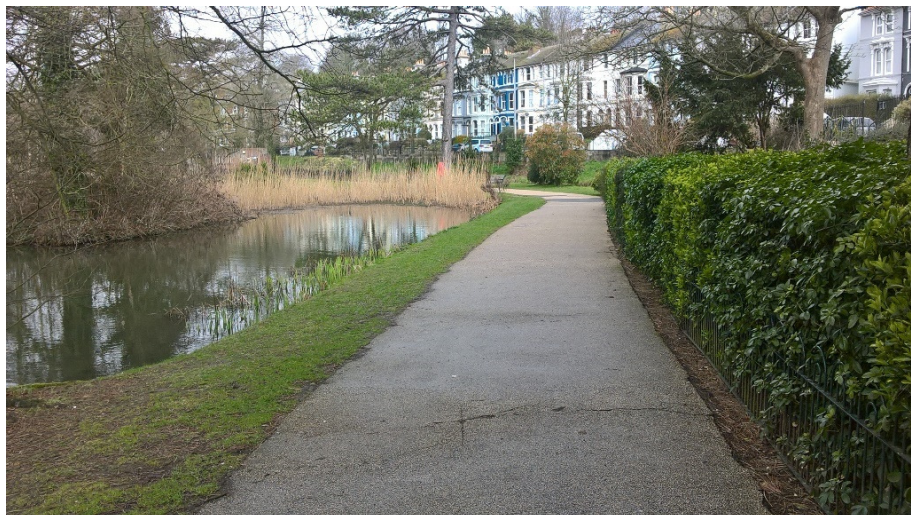
Option 4 Section F: Limited width to widen path to increase clearance to water feature.
