## Appendix 4 - Traffic Data Analysis

# 1.1 Traffic Speed Surveys

# 1.5 Video Observations Surveys

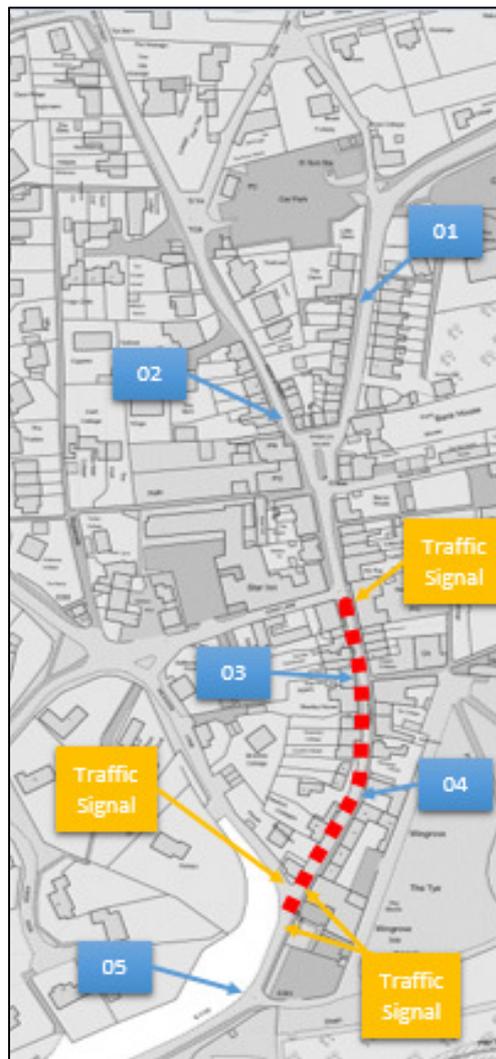
Figure 1.1.1: Location of Monitoring Sites

To determine the impact the temporary traffic signals and 20mph speed limit had on traffic speeds within the village, traffic speed data was collected at five locations along the High Street, North Street and West Street during the trial period. The locations of the monitoring sites corresponded to sites where traffic speed data was captured during 2016.

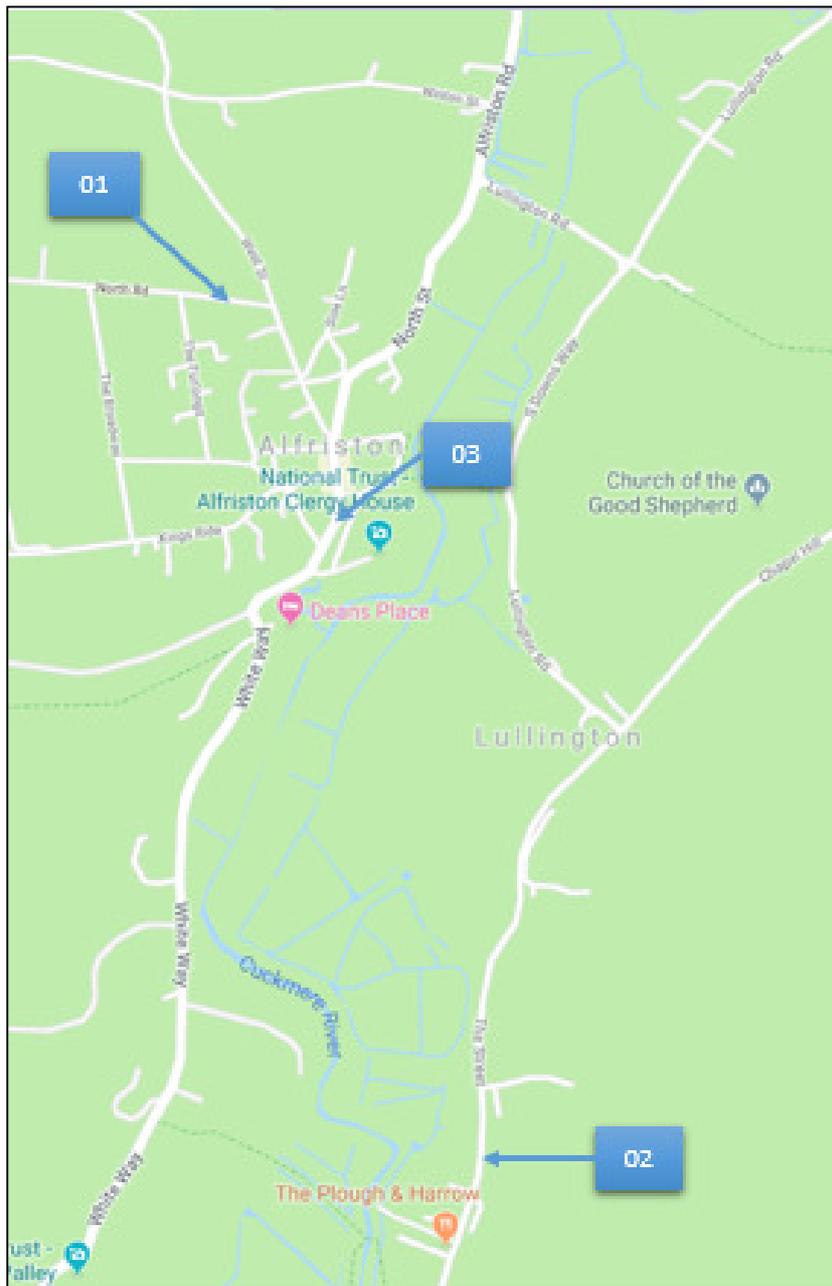
Figure 1.3.1: Location of Monitoring Sites

The introduction of traffic signals created a risk that traffic would avoid Alfriston High Street and use alternative routes. Monitoring sites were set up in the High Street, on North Road and on The Street in Lullington to record fluctuations in traffic flows during and after the traffic signals were in operation, as shown in Figure 1.3.1 below.

Site 01 – North Road  
Site 02 – The Street  
Site 03 – The High Street

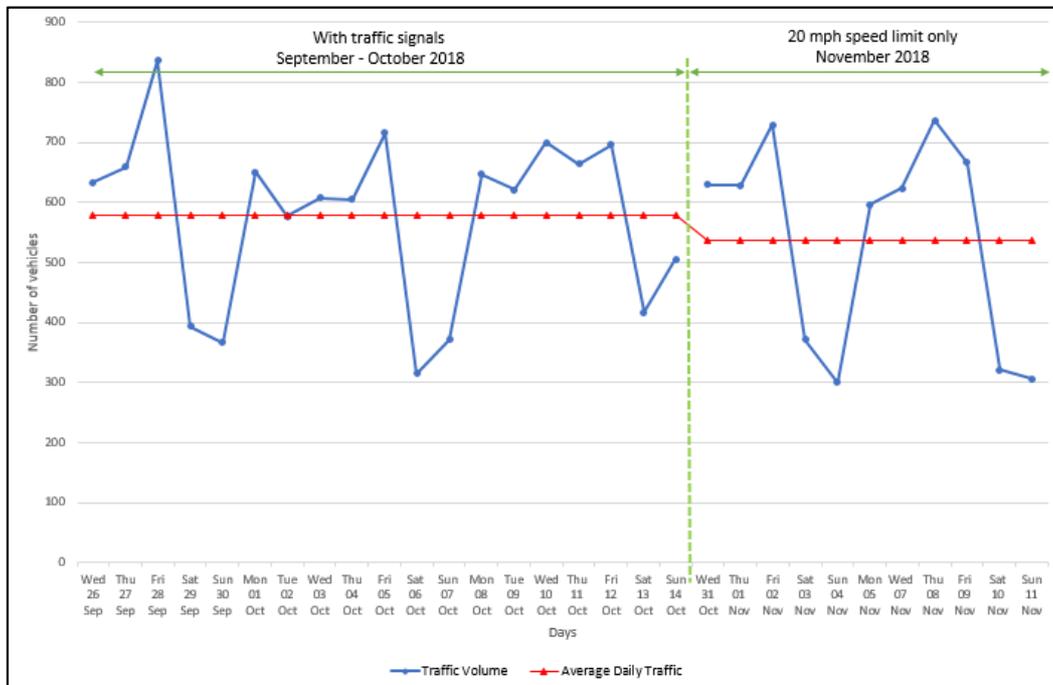
Figure 1.3.2: Site 01, North Road Traffic Count Surveys Results

Figures 1.3.2, 1.3.3 and 1.3.4 provide a summary of the daily traffic flows recorded from the traffic count surveys on North Road, The Street and the High Street respectively.

Based on the information gathered at Sites 01 and 02, traffic flows did increase whilst the traffic signals were in operation. Average daily traffic flow increased by 8% and 21% on North Road and The Street respectively.

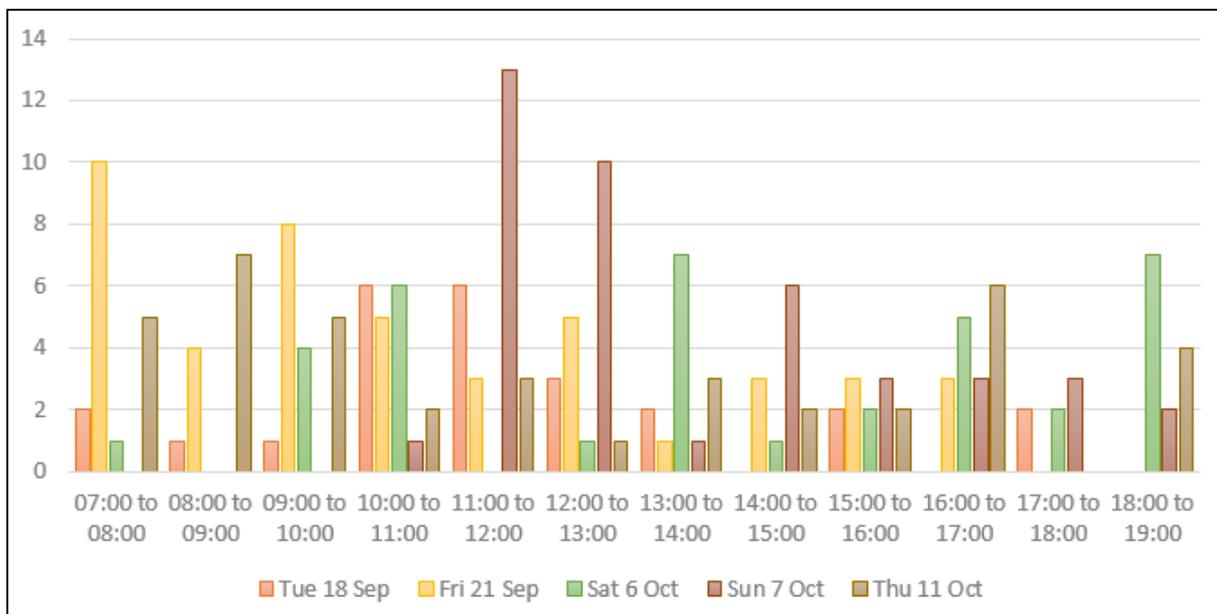
Figure 1.5.1 Frequency of footway overrun at Weavers Lane junction.

Site observations and video survey footage indicated the eastern footway, by Wingrove House, was regularly overrun by southbound traffic. The narrow carriageway width coupled with queuing stationary northbound traffic at the traffic signals resulted in southbound traffic occasionally having to use the footway to pass. The frequency of this occurrence is illustrated in figure 1.5.1 below.

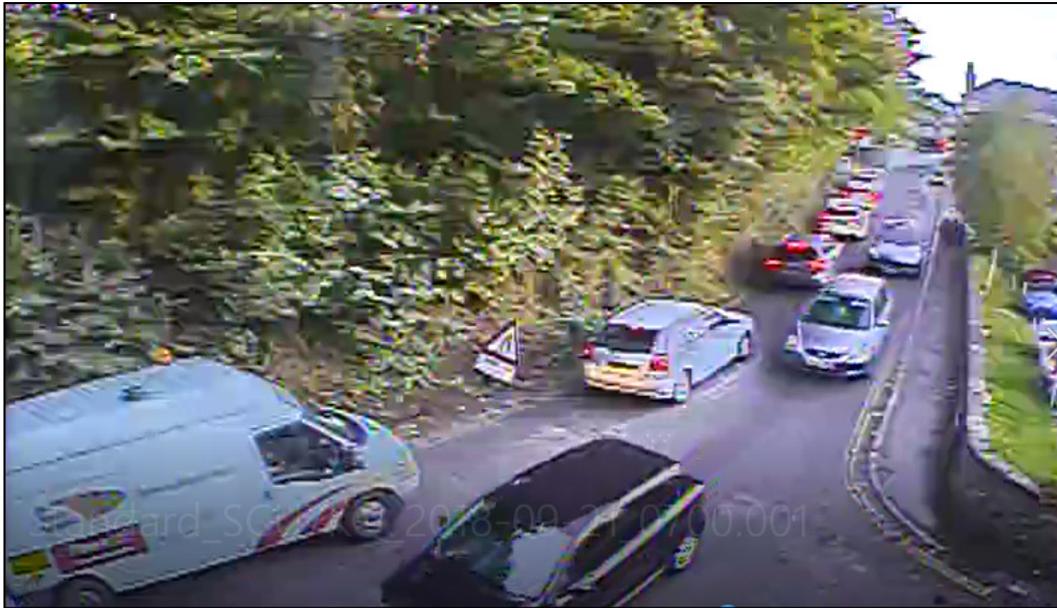
*Photograph 1.5.1 View looking north towards Weavers Lane. Northbound traffic queuing at traffic signals whilst southbound traffic passes. Southbound vehicles often over-ran the footway adjacent to Wingrove House.*

Weavers Lane itself was not covered by the video footage. Supplementary site observations together with community feedback indicated the limited carriageway width at the point where vehicles were instructed to wait at the signals hampered two-way traffic movement. In turn this prevented vehicles exiting the High Street into Weavers Lane and resulted in congestion as traffic could not clear the junction. Should a permanent traffic signal solution be taken forward, a review of the location of the stop line will be needed to ensure opposing traffic can pass on Weavers Lane to prevent traffic blocking back into the High Street.

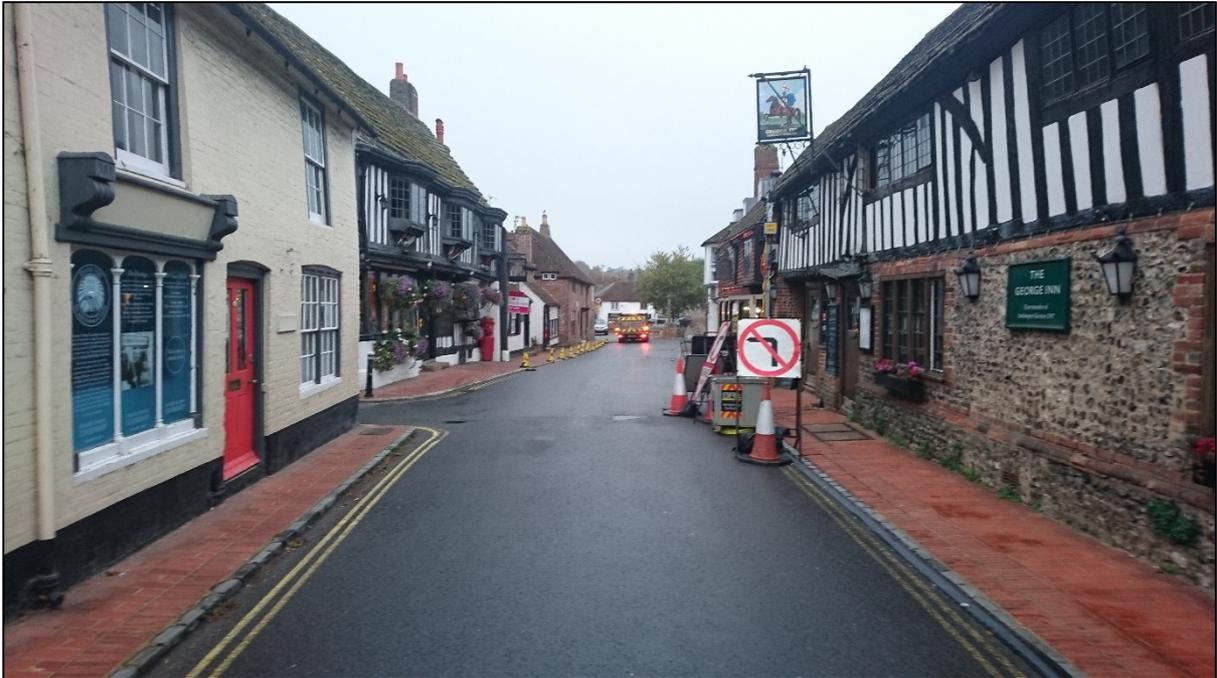
*Photograph 1.5.2 View looking north along the High Street towards Star Lane. Temporary 'left turn' ban imposed during trial period preventing northbound traffic entering Star Lane.*

Based on observations made during the trial, should traffic signals be introduced, it would be recommended Star Lane be converted to a one-way road preventing vehicle access onto the High Street.

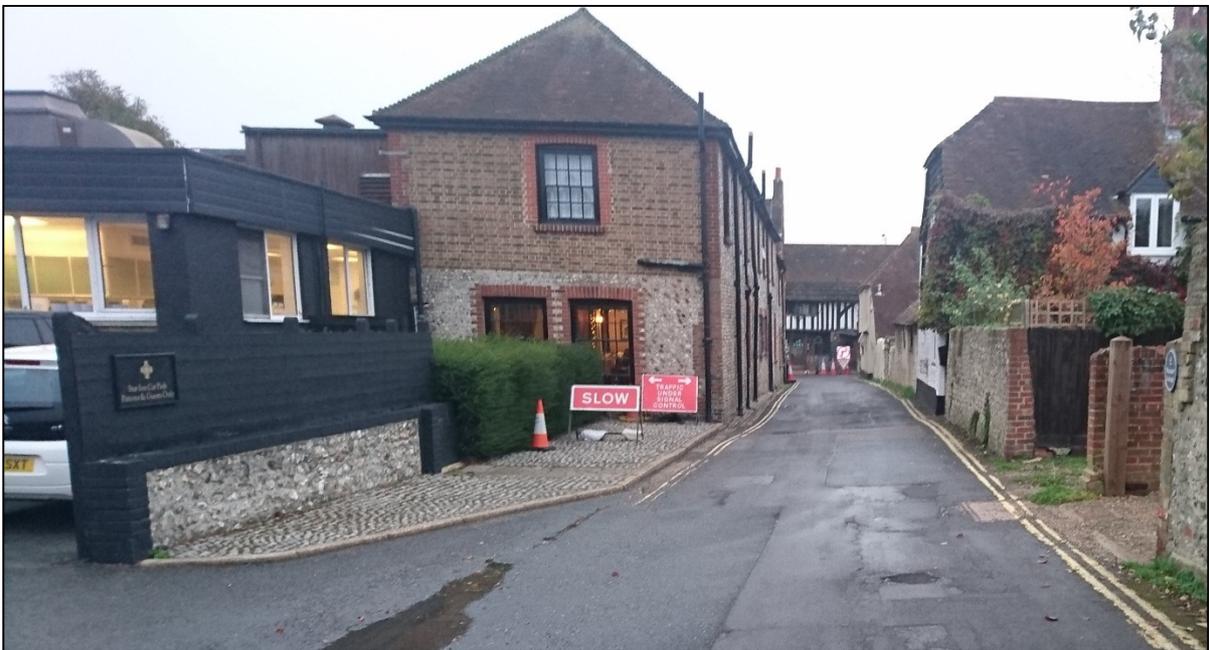
*Photograph 1.5.3 View looking towards the High Street from Star Lane. Temporary 'right turn' ban imposed during trial period preventing traffic turning right out of Star Lane.*

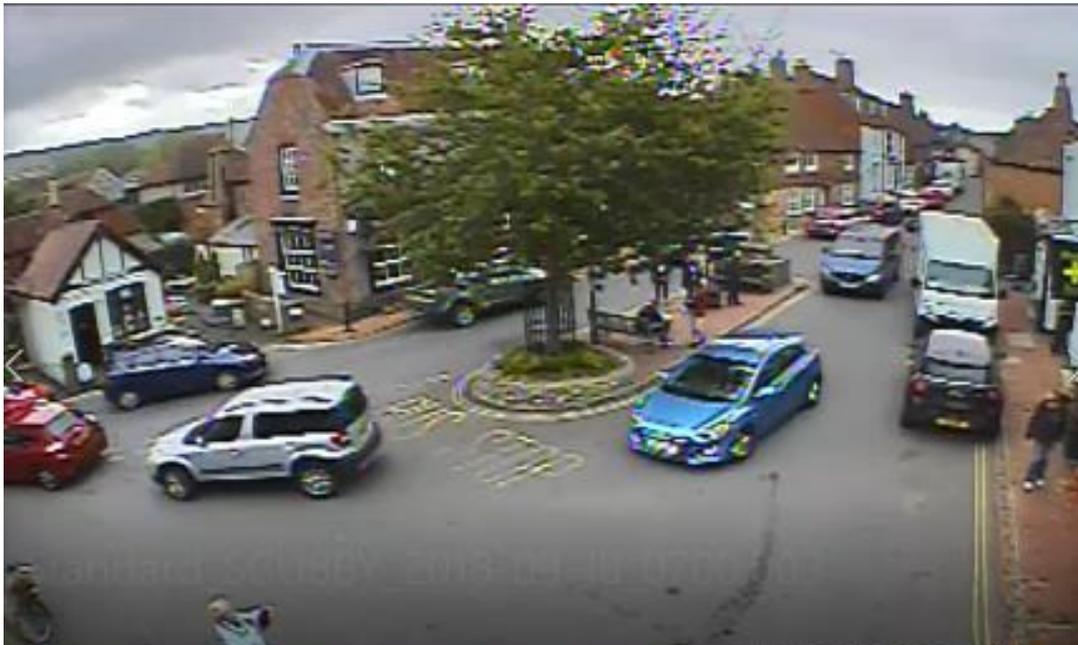
Photograph 1.5.4 Northbound traffic passing on the west side of the island due to southbound queues.

As the queue length surveys indicated, the traffic signals performed well in clearing queuing traffic in a signal cycle. However, the video observations demonstrated northbound vehicles were regularly passing on the west side of Market Square because of queuing southbound traffic from Star Lane. This is shown in the following photograph.

Whilst the trial increased the distance between the stop line and Market Square when compared to the 2016 consultation proposals, this still only provided sufficient space to allow seven to eight vehicles to queue. Any increase in this queue would generally see northbound vehicles being re-directed on the west side of the island. As shown in figure 1.5.2 this was observed throughout the day and not just during peak periods.

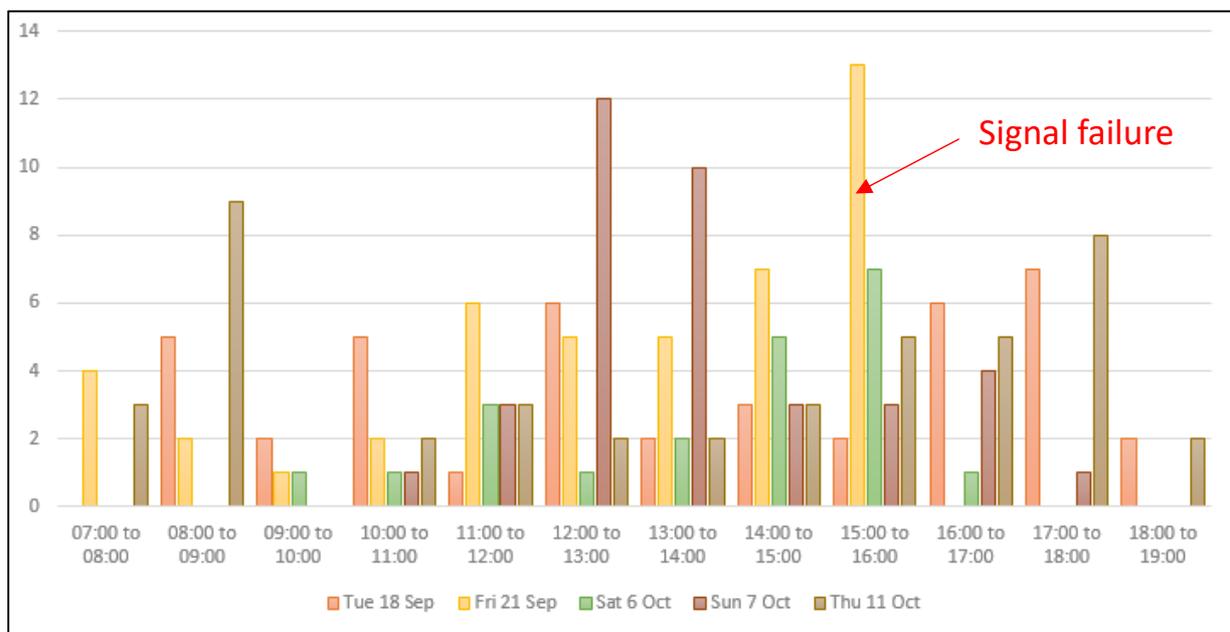
Figure 1.5.2 Frequency of vehicles queuing back past Market Square

(Note: On Friday 21 September between 15:00 and 16:00 the traffic signals failed, creating excessive queues. The signals were subsequently switched off over the following weekend)

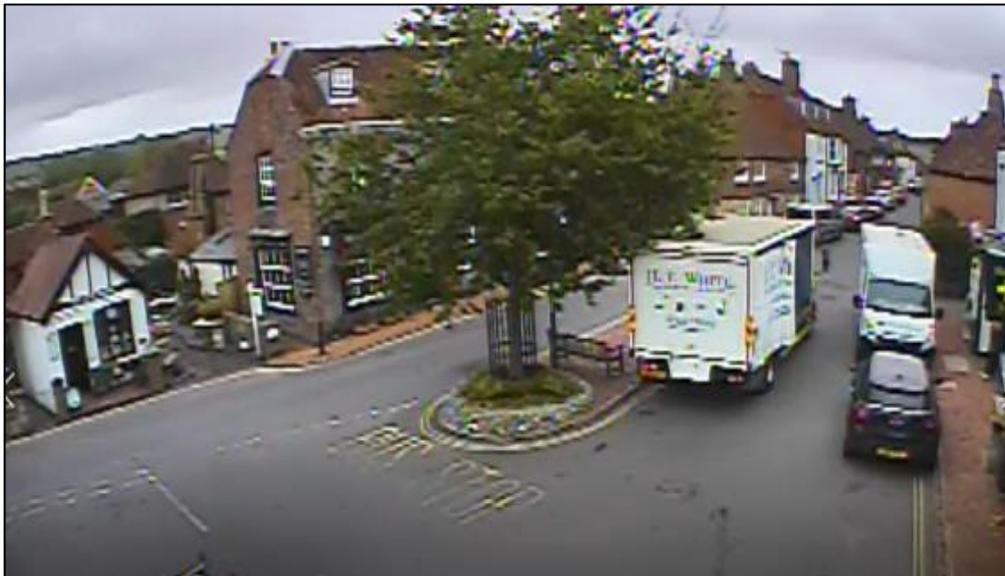
Congestion was exacerbated at Market Square when delivery vehicles were present, as these generally blocked the route for northbound traffic. This is shown in the following photographs.

*Photograph 1.5.5 Delivery vehicle at Market Square blocking west side of island.*

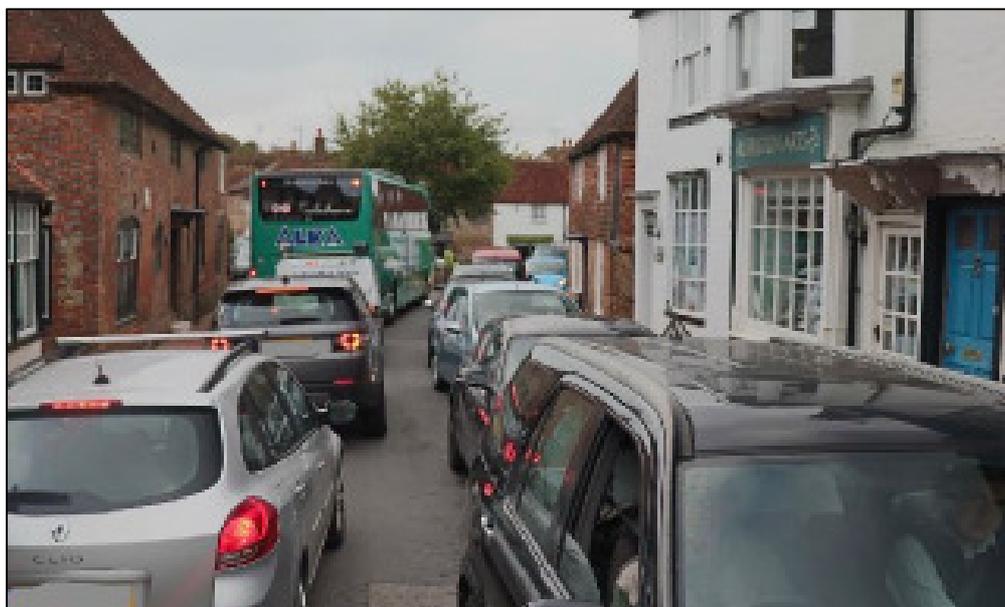
*Photograph 1.5.6 'Grid lock' situation because of southbound vehicle queues and congestion at Market Square.*

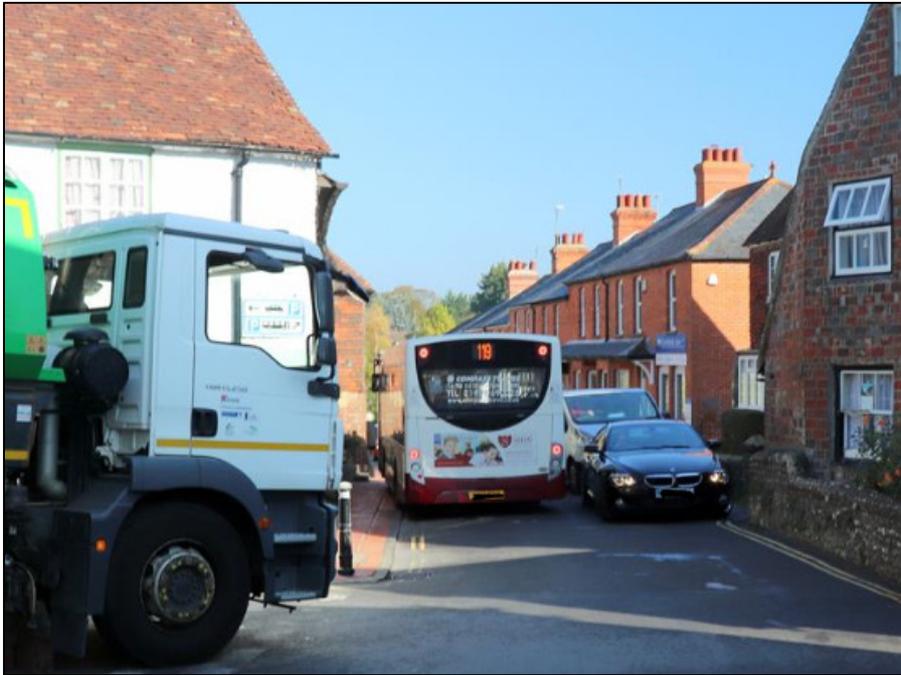
At North Street, based on the survey results, southbound vehicle queues did extend into North Street from Market Square. Whilst camera footage was unable to pick up this occurrence, community feedback together with on-site observations recorded instances where northbound traffic had to mount the footway to pass southbound queuing traffic, as shown in the following photograph. Given the narrow highway corridor, vehicles were at times passing close to property frontages. No instances of property damage were reported to East Sussex Highways during the trial period.

*Photograph 1.5.7 Footway over-run observed along North Street as northbound traffic tried to pass southbound queues.*
