Hastings Green Connections and Public Realm

East Sussex County Council
Public Realm Access & Inclusion Audit – Study area

HPRGC-ARUP-ZZ-XX-SP-OH-000001

ISSUE | 17th June 2024

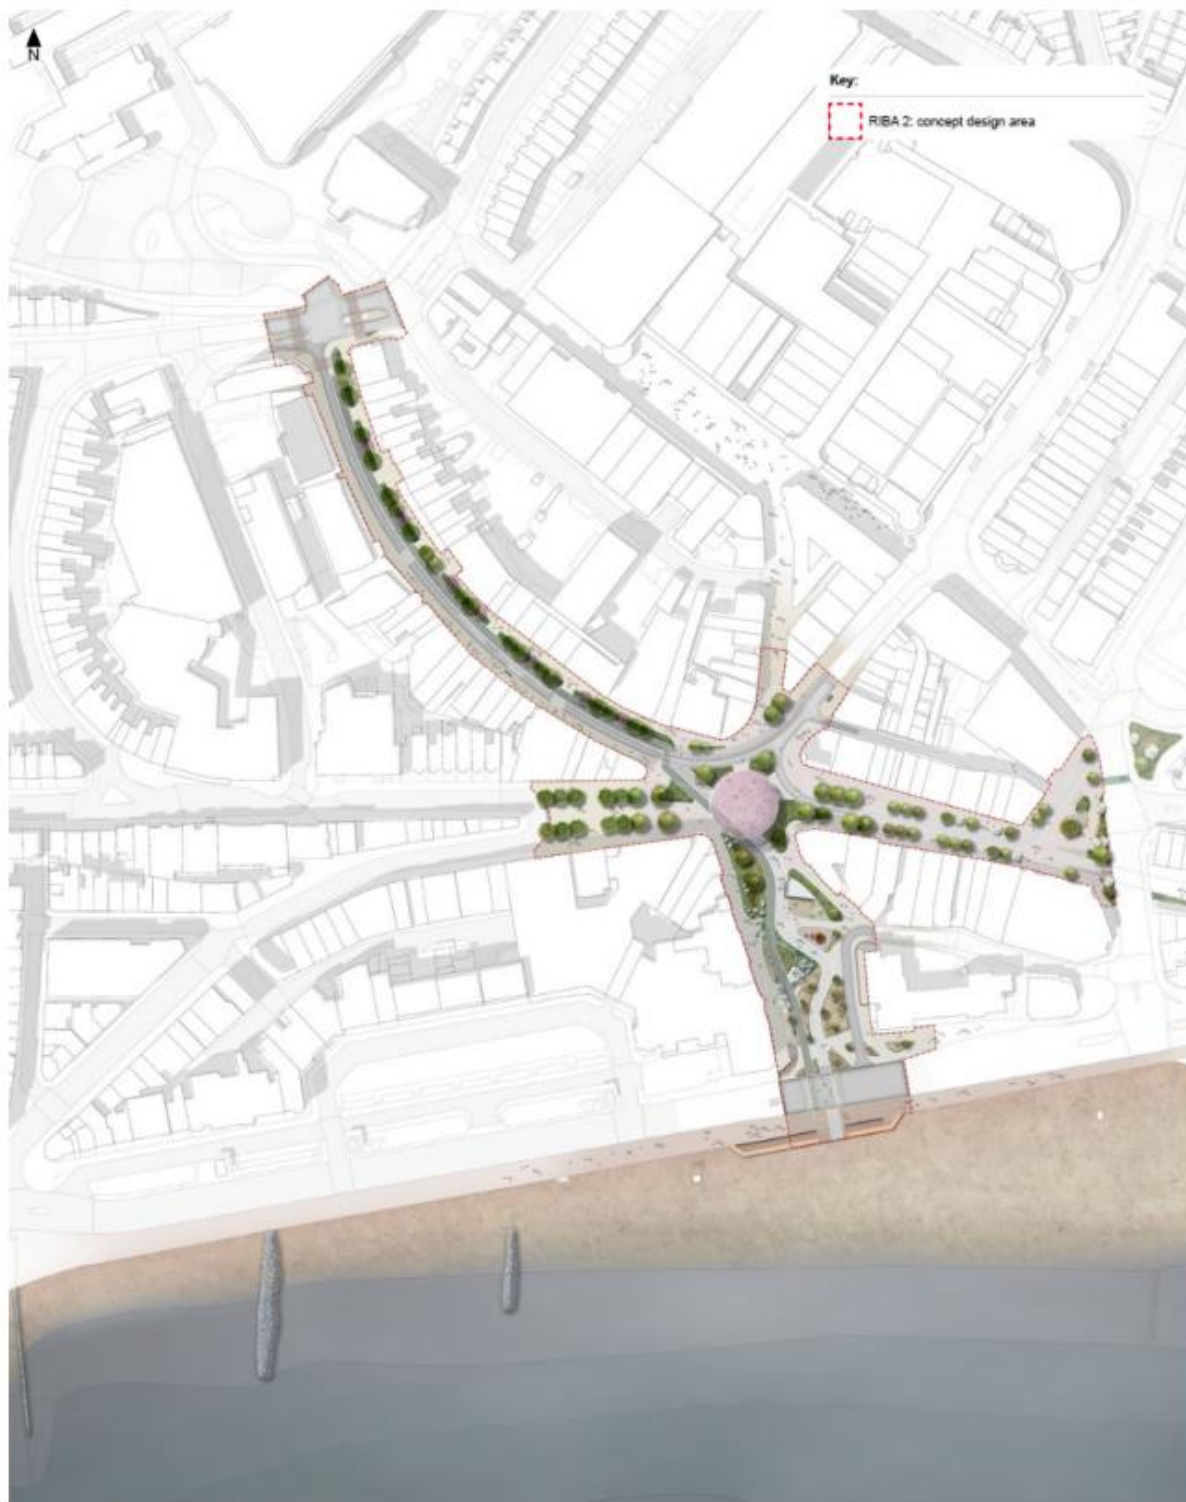
Figure 1 Hastings Town Centre Public Realm and Green Connections red line boundary

Extents of the project red-line boundary, as determined through the original RIBA 2 design

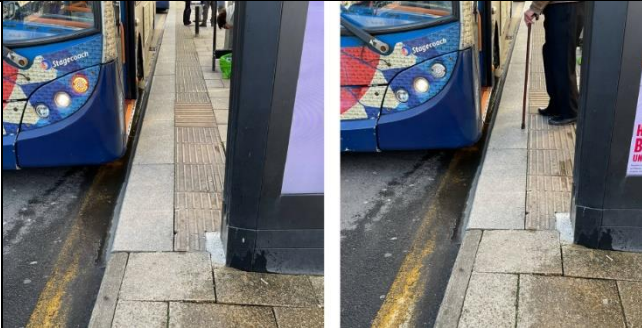
Location	Description	Image	Recommendations	Suggested actions
Havelock Road	There is tactile paving along the bus stop with some facing in a different direction. However, there is no indication what this is for, and it is not present on other bus stops.

<p>Minimum recommendation</p> <p>N/A</p>	Tactile paving that is decommissioned or no longer required should be removed as this can cause confusion when it is not clear what the warning surface is for.
			<p>Good practice</p> <p>It is important that wherever a crossing is decommissioned or relocated, the blister surface is removed (crossing specific).</p>	
			<p>Best in class</p> <p>Where tactile paving is no longer required it should be removed to avoid confusion.</p>	
Havelock Road	There are limited resting places throughout and where these are present, they do not vary in type.

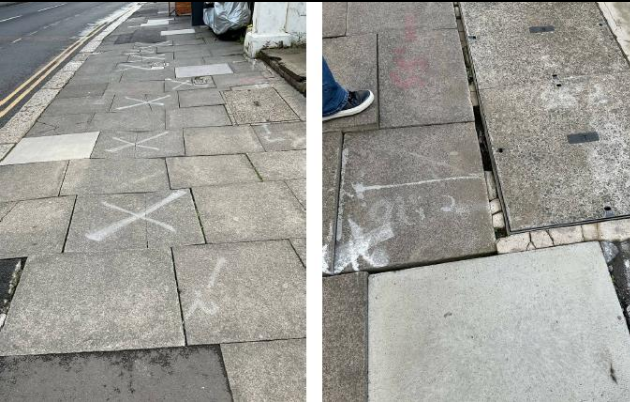
Location	Description	Image	Recommendations	Suggested actions
Havelock Road	Paving along the road is broken, loose and uneven meaning the walking and wheeling surface is not comfortable to use and presents a trip hazard.

<p>Minimum recommendation</p> <p>Ground surfaces should be firm, durable and slip resistant.</p> <p>Good practice</p> <p>Uneven surfaces, surfaces of loose materials (e.g. unbonded gravel), and large gaps between paving materials cause problems for wheelchair users, people who are blind or partially sighted and people who are, generally, unsteady on their feet.</p> <p>Best in class</p> <p>Access routes should have firm, slip resistant surfaces. Any damaged paving should be replaced with a like-for-like replacement.</p>	Any damaged paving should be replaced with a like-for-like replacement to provide a level and consistent surface.
Havelock Road	There are no tactile hazard warnings on steps on building edges or steps to enter lowered store fronts.

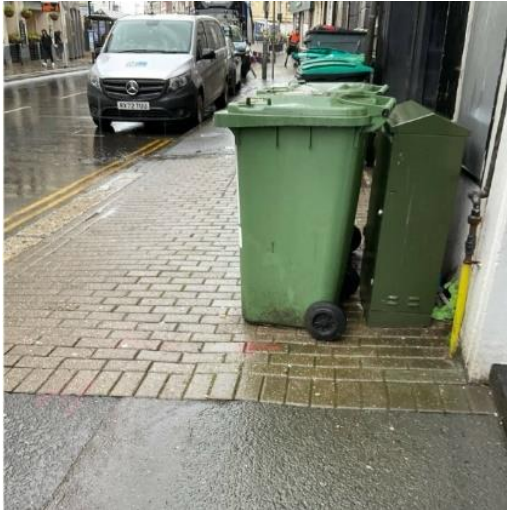
Location	Description	Image	Recommendations	Suggested actions
Havelock Road	There are areas on the footway where the circulation width is reduced to less than 1500mm due to placement of both commercial and residential bins.

<p>Minimum recommendation</p> <p>An unobstructed 1800mm width can accommodate pedestrian routes without need for passing places.</p> <p>Good practice</p> <p>For a pedestrian route to be accessible, the minimum unobstructed surface width of an access route (i.e. between walls, kerbs, or path edgings) should be at least 1800mm for general routes.</p> <p>Best in class</p> <p>As per good practice although a width of 2000mm is preferred to accommodate larger electric mobility scooters.</p>	Access routes should be kept clear of obstructions to allow all road users to move without having to enter vehicle traffic areas. Where possible, bins and other obstructions should be stored in locations where they do not pose a hazard to pedestrians.

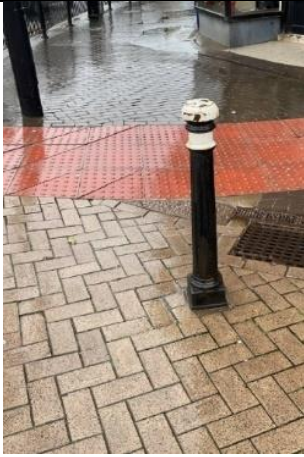
Havelock Road	<p>Bollards across the town centre vary in design and are mainly 930mm tall from ground level.</p> <p>Most are provided with good visual contrast with a contrasting top and a band to help with identification</p>

<p>Minimum recommendation</p> <p>N/A</p> <p>Good practice</p> <p>Bollards should contrast with the background seen against and be at least 1000mm high from ground level.</p> <p>Best in class</p> <p>Bollards in spaces should be consistent in design and height.</p>	Bollards should be at least 1000mm high and be finished with the same contrasting band.

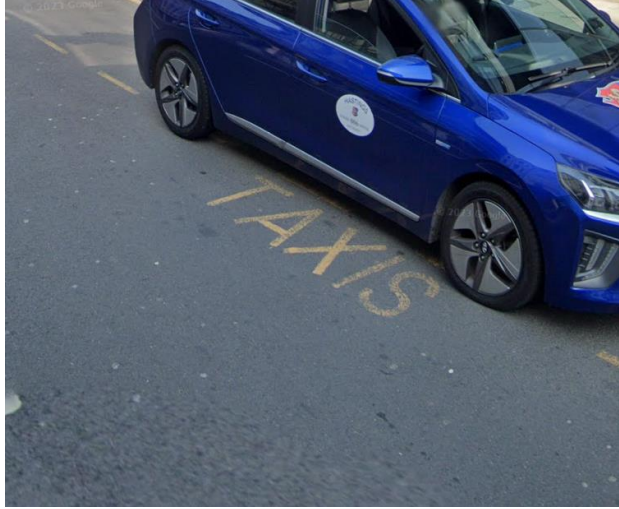
Location	Description	Image	Recommendations	Suggested actions
Havelock Road	There is limited signage to indicate that the taxi rank is where it is (only signage at ground level).

<p>Minimum recommendation</p> <p>Drop off points should be clearly signed.</p>	Provide signage to car pick up and drop off points around the public realm so that users arriving at the bus and train station know where these are located.
			<p>Good practice</p> <p>N/A</p>	
			<p>Best in class</p> <p>As per minimum recommendation.</p>

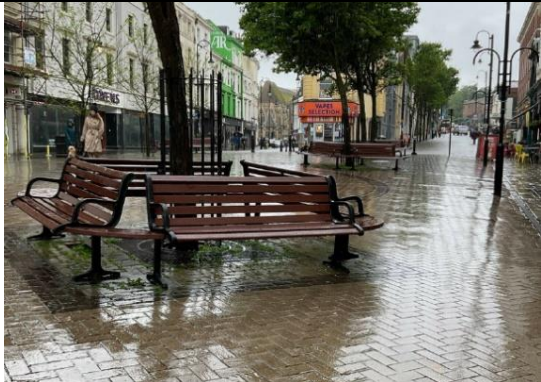
Location	Description	Image	Recommendations	Suggested actions
Robertson Street	There is limited choice in seating types with no opportunity for people to pull alongside the seating or transfer. There are also no covered resting places throughout.

<p>Minimum recommendation</p> <p>N/A</p>	<p>Provide different seating types to assist with differing access requirement – including perch seating and seats with arm and back rests.</p>
			<p>Good practice</p> <p>Provide a range of seating types (e.g. various seat heights (380mm,480mm & 580mm from FFL), provision of arm and backrests) to suite a variety of needs. There should also be provisions for wheelchair transfer spaces.</p>	<p>Provide space next to the seats to allow someone to sit alongside others and providing some seats with an open end will allow someone to transfer.</p>
			<p>Best in class</p> <p>As per good practice, including providing shelter from the elements.</p>	<p>Explore means of providing a range of both sheltered and unsheltered seating throughout the town centre. Sheltered seating may include canopies, which can be permanent or temporary fixtures.</p>

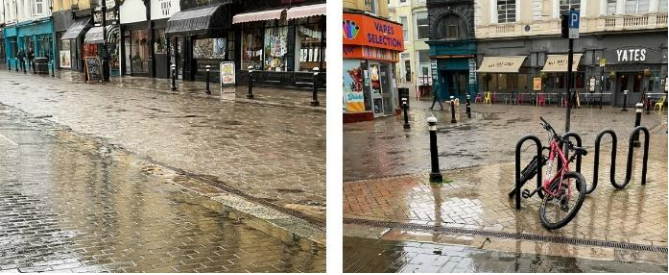
Location	Description	Image	Recommendations	Suggested actions
Robertson Street	<p>There is currently no means of separating pedestrian and car routes, apart from bollards which do not extend the whole route.</p> <p>There is no raised kerb between the footway and road. There is a drainage channel along the kerb edge and a mixture of street furniture and bollards.</p>

<p>Minimum recommendation N/A</p> <p>Good practice N/A</p> <p>Best in class Shared surfaces should be avoided where possible. Where surfaces are to be shared there should be tactile and visual difference between surfaces.</p>	<p>Consider installing a detectable kerb edge in areas where the vehicle and pedestrian surface is flush. As bollards are in already in place along the street, extending this could also be an alternative approach.</p>

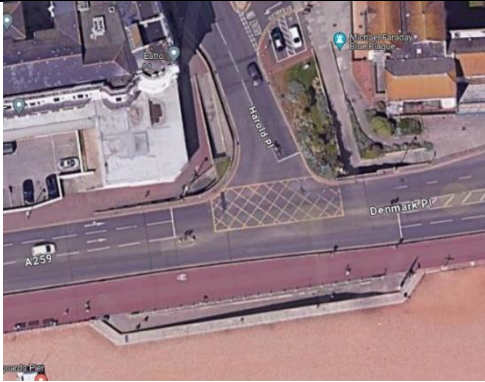
Location	Description	Image	Recommendations	Suggested actions
<p>Harold Place/Denmark Place</p>	<p>To cross Denmark Place you need to use the subway and there is no alternative street level crossing point available. Users are forced to use the underground subway which, at night, may cause an issue in terms of safety and perceptions of safety.</p>

<p>Minimum recommendation</p> <p>N/A</p>	<p>Improve the look and feel of the subway by improving the surface finishes. Lighting should be consistent throughout the subway both during day and night hours.</p> <p>A surface level controlled crossing should be considered to provide users with a choice.</p>
			<p>Good practice</p> <p>An alternative street level crossing should be available.</p> <p>Remote, hidden locations should be avoided to discourage opportunities for anti-social behaviour. Features that may be considered in subways include:</p> <ul style="list-style-type: none"> - Security cameras; - Avoidance of shadows and potential hidden locations; - Clear views from one side of the route to the other; - Materials and barriers that enhance sight lines; - Suitable lux levels to ensure good visibility appropriate to the area.

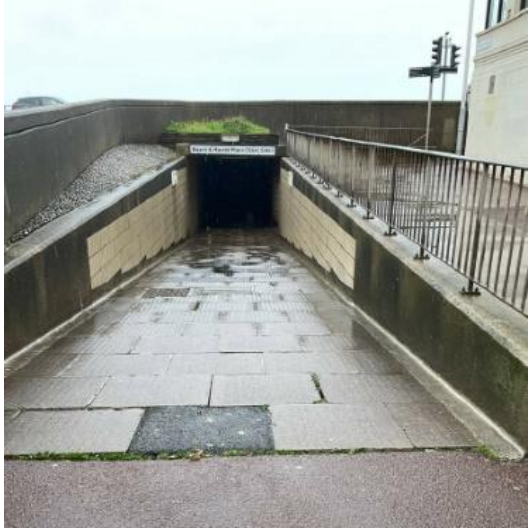
Location	Description	Image	Recommendations	Suggested actions
Harold Place entrance	The ramped gradient to the subway is 1:12. There are no handrails.

<p>Minimum recommendation</p> <p>When gradients cannot be avoided, these should be between 1:12 - 1:20 with a crossfall of no greater than 1:40 and landings as per table 1 of ADM (minimum), or between 1:21 - 1:60 with landings every 500mm rise (preferred).</p> <p>Where the rise is greater than 2m, a lift should be available (ADM cl. 1.26 – see Appendix A.2).</p> <p>Handrails should be provided on both sides of the ramp and be positioned 900-1000 from the surface of a ramp and 900mm – 1100mm from landing.</p> <p>Good practice</p> <p>As per minimum recommendation, with the exception of having crossfalls shallower than 1:50. A second handrail mounted at 600mm from the ramp surface may also be beneficial for those of shorter stature and children.</p> <p>Best in class</p> <p>As per good practice, with additional consideration on protecting external lifts from the elements if these are provided (noted that lift access may not be feasible for this area as will have management and operational considerations).</p>	<p>If work was to be undertaken on the subway, then consideration should be taken to making the gradient of the ramp shallower. Handrails should be provided on both sides of the ramp to allow users to steady themselves.</p> <p>Consider providing a surface level controlled crossing to provide users a choice.</p>

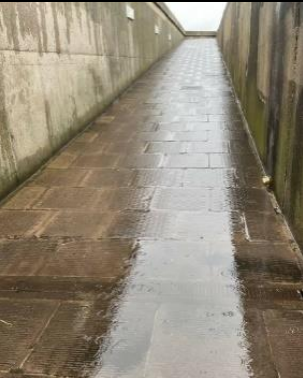
Location	Description	Image	Recommendations	Suggested actions
Subway seafront entrance	The ramped gradient to the subway is 1:11 which is steeper than recommendations in ADM. There are no handrails.

<p>Minimum recommendation</p> <p>When gradients cannot be avoided, these should be between 1:12 - 1:20 with a crossfall of no greater than 1:40 and landings as per table 1 of ADM (minimum), or between 1:21 - 1:60 with landings every 500mm rise (preferred).</p> <p>Where the rise is greater than 2m, a lift should be available (ADM cl. 1.26).</p> <p>Handrails should be provided on both sides of the ramp and be positioned 900-1000 from the surface of a ramp and 900mm – 1100mm from landing.</p> <hr/> <p>Good practice</p> <p>As per minimum recommendation, with the exception of having crossfalls shallower than 1:50. A second handrail mounted at 600mm from the ramp surface may also be beneficial for those of shorter stature and children.</p> <hr/> <p>Best in class</p> <p>As per good practice, with additional consideration on protecting external lifts from the elements if these are provided (noted that lift access may not be feasible for this area as will have management and operational considerations).</p>	<p>If work was to be undertaken on the subway, then consideration should be taken making the gradient of the ramp shallower. Handrails should be provided on both sides of the ramp to allow users to steady themselves.</p> <p>Consider providing a surface level controlled crossing to provide choice to users.</p>

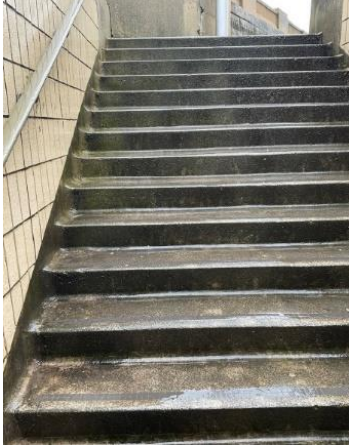
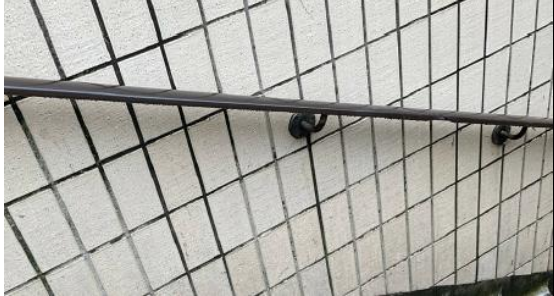
Location	Description	Image	Recommendations	Suggested actions
<p>Subway Harold Place entrance</p>	<p>Handrails are a flat top profile, these are 65mm wide and 20mm deep.</p>

<p>Minimum recommendation</p> <p>Circular handrails should be a maximum of 50mm.</p> <p>A handrail with an oval profile should have dimensions of 50mm wide and 39mm deep. The profile should have rounded edges with a radius of at least 15mm.</p> <p>There should be a clearance of between 50mm and 75mm between a handrail and any adjacent wall surface.</p>	<p>This handrail meets the guidance but is not consistent in design to the other handrails throughout the town centre. If being changed, these should be designed to match the alternative routes around the town centre.</p>

<p>Good practice</p> <p>An external perimeter between 100mm and 160mm is the optimum size to provide grip. A flatter profile gives better forearm support.</p>

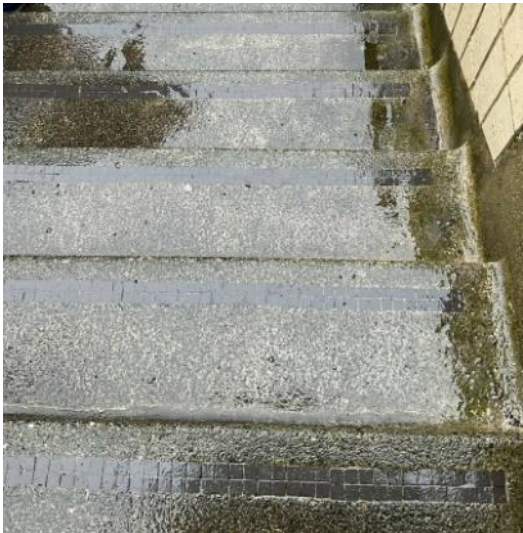
Location	Description	Image	Recommendations	Suggested actions
Subway Harold Place entrance	<p>The stairs have a 150mm rise and 290mm going.</p> <p>There are only contrasting nosings on the going, however these do not provided sufficient tonal contrast when wet.</p>

<p>Minimum recommendation</p> <p>All nosings should be made apparent by means of a permanently contrasting material 55mm wide on both the going and riser.</p> <hr/> <p>Good practice</p> <p>The visually contrasting nosing should extend 50mm to 65mm in width from the front edge of the tread and 30mm to 55mm from the top of the riser.</p> <hr/> <p>Best in class</p> <p>Consideration should also be given to adopting integrated lighting to help legibility / safe use of the stair / identification of the handrails in lower lighting levels.</p>	<p>Contrasting nosings should be installed. These should provide a 30 LRV difference in all weather conditions and be on both the rise and going of steps.</p>

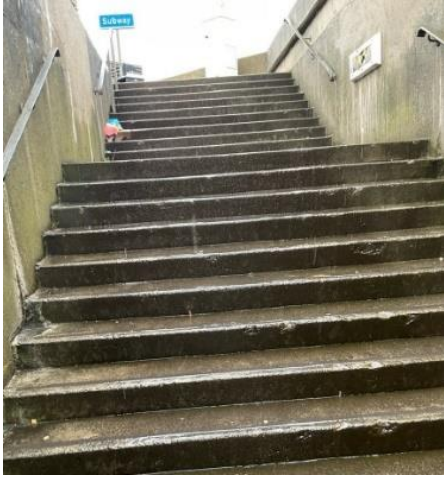
Location	Description	Image	Recommendations	Suggested actions
Subway seafront entrance	Stairs have goings of 290mm. The risers are generally 180mm but the bottom step is only 150mm.

<p>Minimum recommendation</p> <p>The rise and going for steps should be consistent in a flight of stairs.</p> <hr/> <p>Good practice</p> <p>As per minimum recommendation.</p> <hr/> <p>Best in class</p> <p>As per minimum recommendation.</p>	Without significant changes to the staircase landings, it will not be possible to create consistent risers. If these are being altered or adjacent paving changes made this should be reviewed.
Subway	There is limited signage throughout the subway.

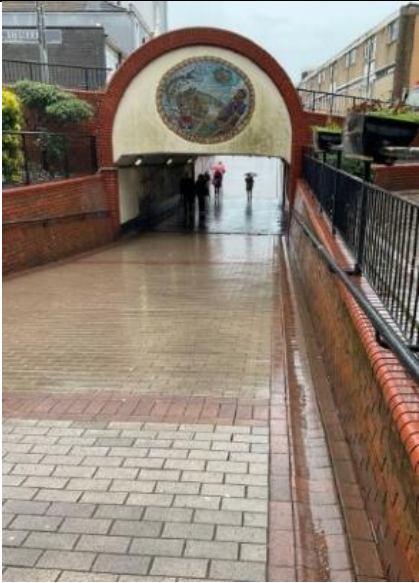
Location	Description	Image	Recommendations	Suggested actions
Wellington Place	Ramps are provided along the route with a 1:12 gradient and approximate 26m. There is only one level landing at the junction between downwards and upward ramps.

<p>Minimum recommendation</p> <p>When gradients cannot be avoided, these should be between 1:12 - 1:20 with a crossfall of no greater than 1:40 and landings as per table 1 of ADM (minimum), or between 1:21 - 1:60 with landings every 500mm rise (preferred).</p> <p>Handrails should be provided on both sides of the ramp and be positioned 900-1000 from the surface of a ramp and 900mm – 1100mm from landing.</p> <p>Good practice</p> <p>As per minimum recommendation, with the exception of having crossfalls shallower than 1:50.</p> <p>Best in class</p> <p>As per good practice.</p>	If work was to be undertaken on the ramp, then consideration should be given to making the gradient of the ramp shallower and introducing level landings for every 500mm rise.

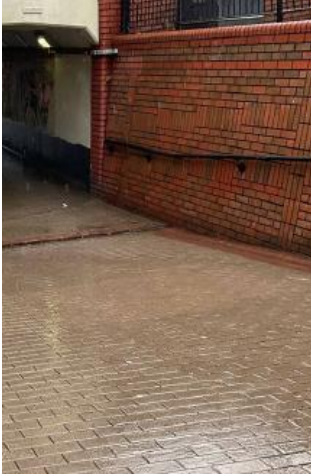
Location	Description	Image	Recommendations	Suggested actions
Wellington Place	The handrail to the ramp is 880mm high.

<p>Minimum recommendation</p> <p>Handrails should be provided on both sides of the ramp and be positioned 900-1000 from the surface of a ramp and 900mm – 1100mm from landing.</p> <p>Good practice</p> <p>As per minimum recommendation, consider a lower handrail at 600mm from surface of the ramp.</p> <p>Best in class</p> <p>As per good practice.</p>	During refurbishment handrails should be positioned 900-1000 from the surface of a ramp and 900mm – 1100mm from landings.

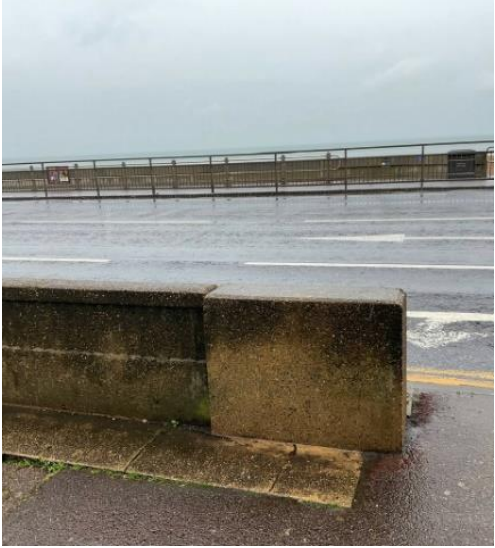
Location	Description	Image	Recommendations	Suggested actions
General	The A259 is busy with traffic in the morning and there are limited crossing places along it due to seafront barriers. Extended travel distances are required to cross the road at a controlled crossing.

<p>Minimum recommendation</p> <p>N/A</p>	<p>Install additional controlled crossing to encourage people to cross the road safely. Desire lines should be reviewed to establish where these are required.</p> <p>Introducing a crossing in close proximity to the subway will also offer flexibility / choice for users.</p>
			<p>Good practice</p> <p>N/A</p>	
			<p>Best in class</p> <p>N/A</p>

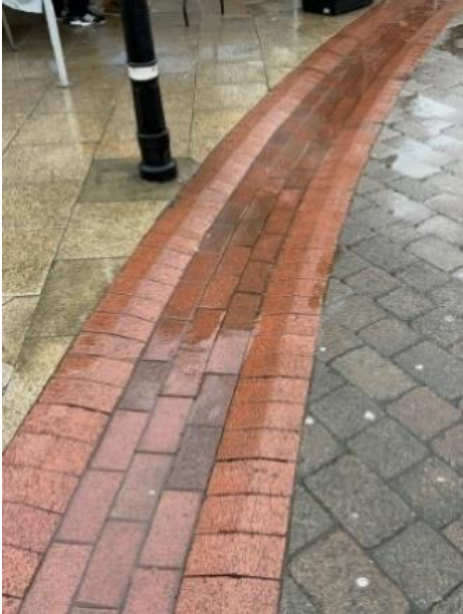
Location	Description	Image	Recommendations	Suggested actions
General	<p>Along Queens Road, drainage channels have been used to demarcate the edge of the footways and the shared road surface.</p> <p>This provides a 3cm deep drainage channel which contrasts visually from the surrounding paving and aids drainage.</p> <p>This is not a traditional detectable kerb. However, in the stakeholder consultation participants were indifferent on the lack of kerb and more concerned on the lack of policing of cyclists and motorcycles in the area.</p>

<p>Minimum recommendation</p> <p>N/A</p> <hr/> <p>Good practice</p> <p>Pedestrian paths should have a detectable demarcation which can be followed by people who are blind or partially sighted, for example a wall, building line, kerb edge, grass verge, barrier, or clearly detectable change in texture of the surface underfoot. Visual contrast should also be provided.</p> <hr/> <p>Best in class</p> <p>As per good practice.</p>	<p>Kerb edges should be detectable both visually (providing visual contrast) and by tactile means. This not only creates a demarcation for blind and partially sighted users but helps create separation between vehicle and pedestrian traffic areas.</p>

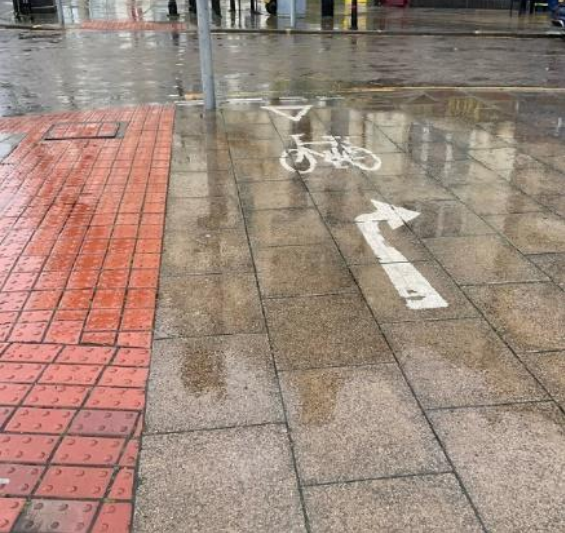
Location	Description	Image	Recommendations	Suggested actions
General	In some areas it is not clear what is a shared surface and what pedestrian / cycle only, until there is signage.

<p>Minimum recommendation</p> <p>N/A</p>	<p>Shared surfaces should be avoided where possible. Any shared surfaces should be clearly demarcated and have a corduroy surface where a footpath joins a cycle track.</p>
			<p>Good practice</p> <p>N/A</p>	
			<p>Best in class</p> <p>Shared surfaces should have a corduroy surface where a footpath joins a cycle track. This should also be used at transitions between footway and areas permitted to be shared by pedestrians and cyclists. (DfT guidance)</p> <p>Figure 28: Layout a junction between a shared route and a carriageway - controlled crossings</p>

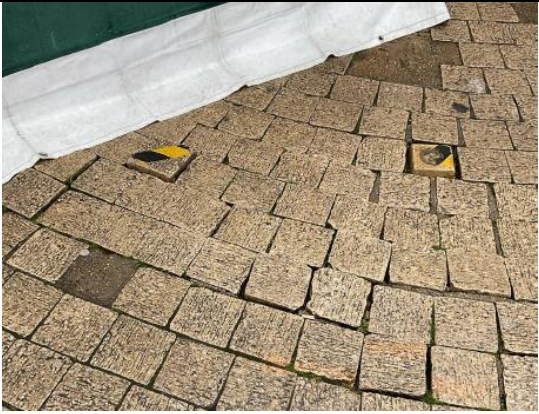
Location	Description	Image	Recommendations	Suggested actions
General	Paving throughout the town centre road is broken, loose and uneven meaning the walking and wheeling surface is not comfortable to use and presents a trip hazard.

<p>Minimum recommendation</p> <p>Ground surfaces should be firm, durable and slip resistant.</p> <hr/> <p>Good practice</p> <p>Uneven surfaces, surfaces of loose materials (e.g. unbonded gravel), large gaps between paving materials cause problems for wheelchair users, people who are blind or partially sighted and people who are, generally, unsteady on their feet.</p> <hr/> <p>Best in class</p> <p>Access routes should have firm, slip resistant surfaces. Any damaged paving should be replaced with a like-for-like replacement.</p>	Access routes should have firm, slip resistant surfaces. Any damaged paving should be replaced with a like-for-like replacement.

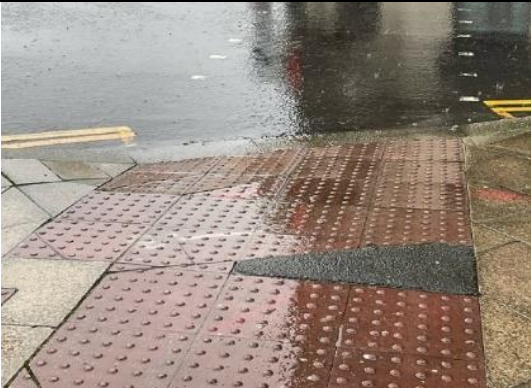
Location	Description	Image	Recommendations	Suggested actions
General	<p>Damaged tactile paving is filled in instead of replaced. This creates gaps in the tactile reading of the paving and may cause confusion for those who are reliant on it (picture example on Havelock Road crossing).</p>

<p>Minimum recommendation</p> <p>Ground surfaces should be firm, durable and slip resistant.</p> <hr/> <p>Good practice</p> <p>Good maintenance of tactile paving surfaces is crucial to their effectiveness. In addition, durability should be a key consideration in the choice of materials used for the surfaces. Post-implementation, as with all surfaces, it is vital to monitor the condition of tactile paving surfaces, and surrounding materials, and to plan for their replacement as part of maintenance programmes. (DfT guidance)</p> <hr/> <p>Best in class</p> <p>As per good practice.</p>	<p>Tactile paving across the town centre should be consistent with nationally recognised standards and when replaced should be done so with a like-for-like replacement to avoid confusion.</p>

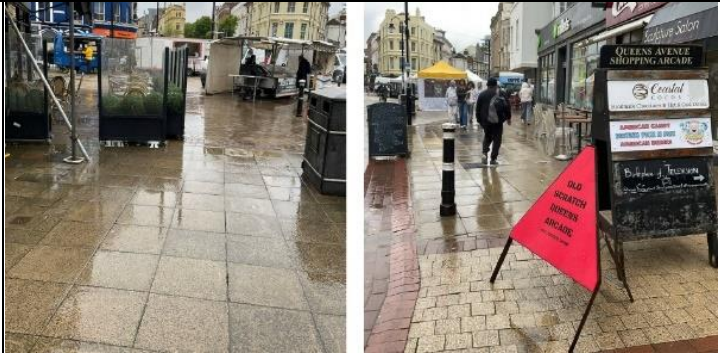
Location	Description	Image	Recommendations	Suggested actions
General	Tables and chairs on paving with no physical barriers create street clutter and hazards.

<p>Minimum recommendation</p> <p>Tables, chairs, and signage boards should not obstruct the minimum clear width of the footway. A (unobstructed) 1800mm width should be maintained</p> <p>Good practice</p> <p>As per minimum standards</p> <p>Best in class</p> <p>2000mm is preferred to accommodate larger electric mobility scooters.</p>	<p>Access routes should be kept clear of obstructions to allow all pedestrians to move without having to enter vehicle traffic surfaces.</p> <p>Where possible bins and other obstructions should be stored in locations where a minimum 1500mm circulation width can still be provided along an access route.</p> <p>Outdoor seating areas should have a physical barrier around them which can be detected by long cane users.</p>

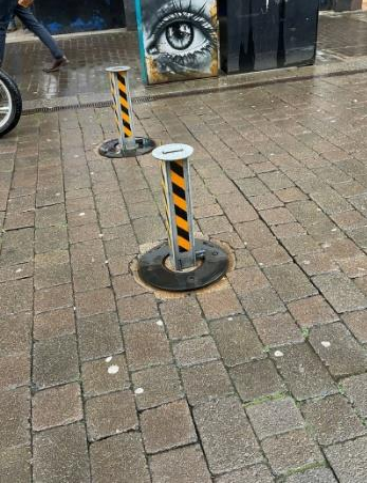
Location	Description	Image	Recommendations	Suggested actions
			<p>Best in class</p> <p>As per good practice.</p>	
General	<p>There are rising bollards throughout the town to prevent vehicle traffic - however these are not maintained and the schedule for rising and dropping these is not consistent.</p>

<p>Minimum recommendation</p> <p>N/A</p> <hr/> <p>Good practice</p> <p>N/A</p> <hr/> <p>Best in class</p> <p>The scheduling of vehicle traffic and non-vehicle traffic should be communicated through signage on the road in the approach to the bollards as well on the council website, so residents and visitors are aware of the operational hours.</p>	<p>The scheduling of vehicle traffic and non-vehicle traffic should be communicated via signage on the road in the approach to the bollards as well on the council website, so residents and visitors are aware of the operational hours.</p> <p>Bollard enforcement should be policed to ensure vehicle traffic does not enter zones during these hours. Explore following a model similar to LTN / bus gates in London.</p>

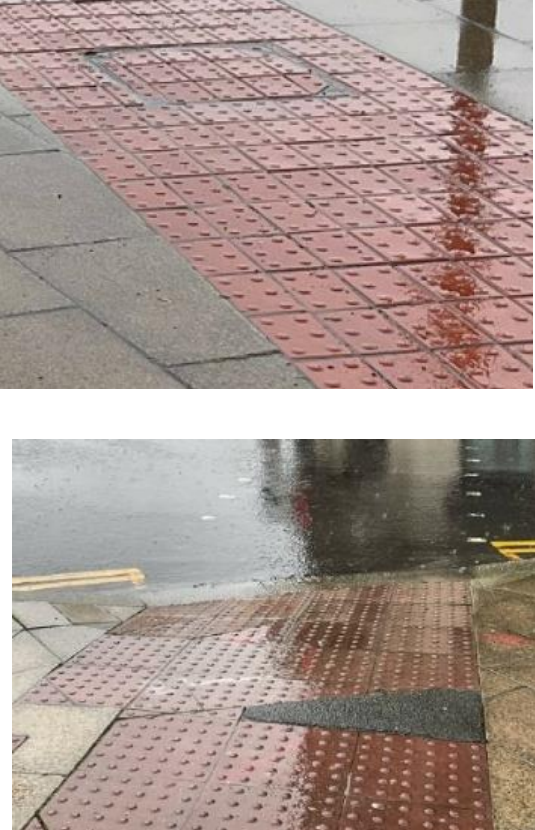
Location	Description	Image	Recommendations	Suggested actions
			<p>Best in class</p> <p>As per good practice, including the following additional considerations: lighting design should consider conditions in both day and night.</p>	
General	Tactile paving varies throughout the town centre.

<p>Minimum recommendation</p> <p>Tactile paving should be installed as per Diagram 1 of ADM. For additional details refer to the Department for Transport Guidance on the Use of Tactile Paving Surfaces 2021.</p> <p>Good practice</p> <p>As per minimum recommendation.</p> <p>Best in class</p> <p>As per minimum recommendation.</p>	All tactile paving throughout the town centre should be reviewed and installed consistently in line with the guidance on tactile paving.
