Report to: Lead Member for Transport and Environment

Date of meeting: 26 February 2018

Title: York Gardens, Hastings, Petition

Purpose: To consider the response to the Petition calling for replacement of the roadway, pavement and kerbs as well as enhancement to street lighting.

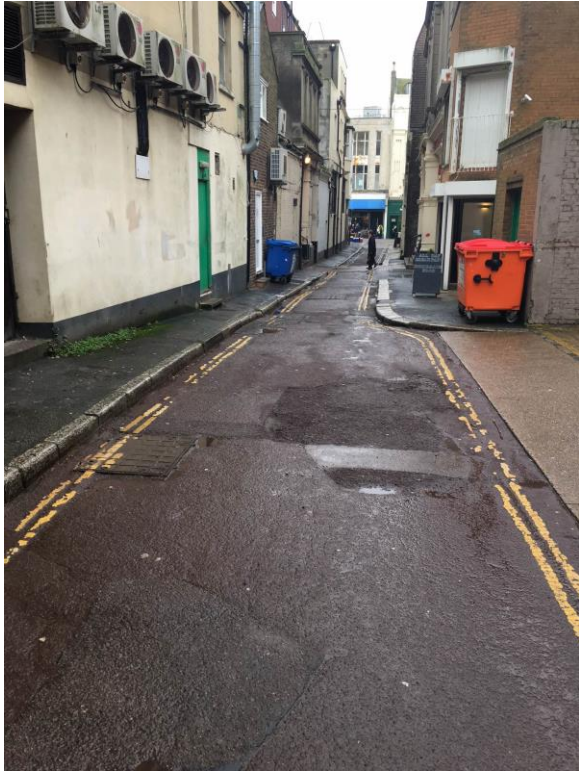
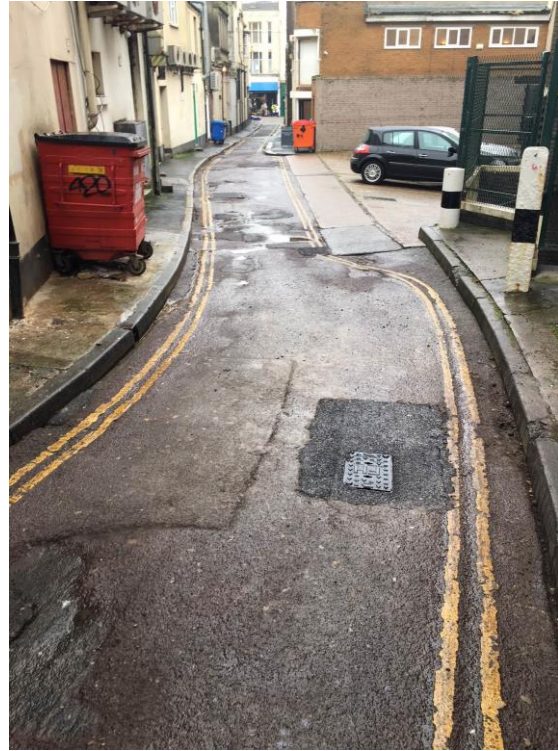
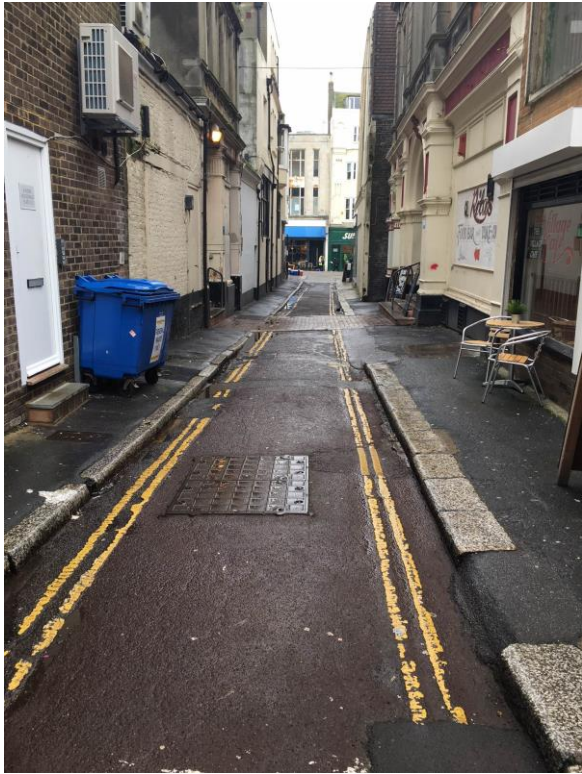
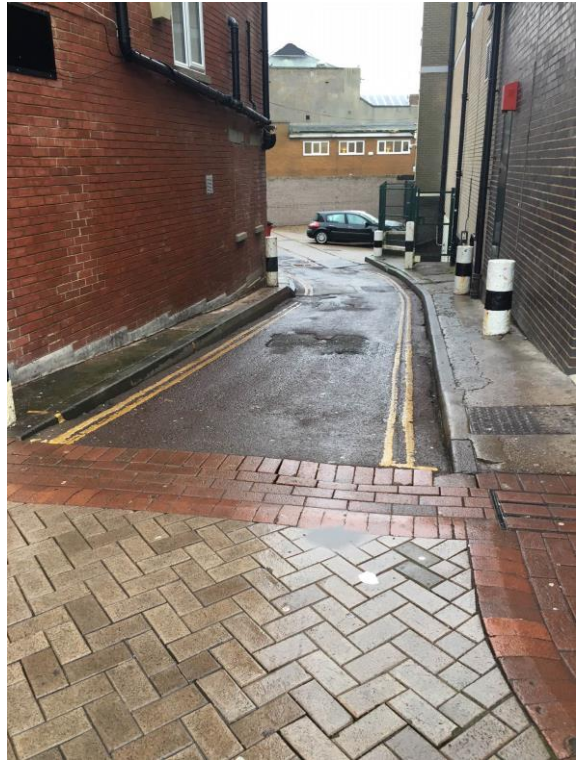
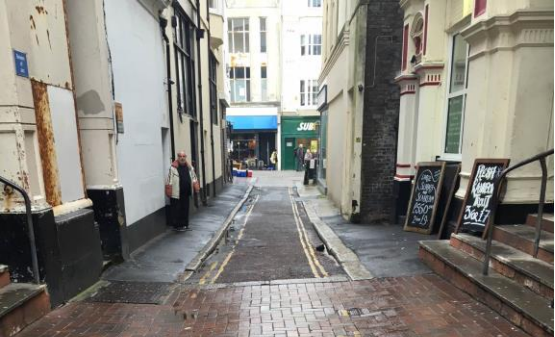
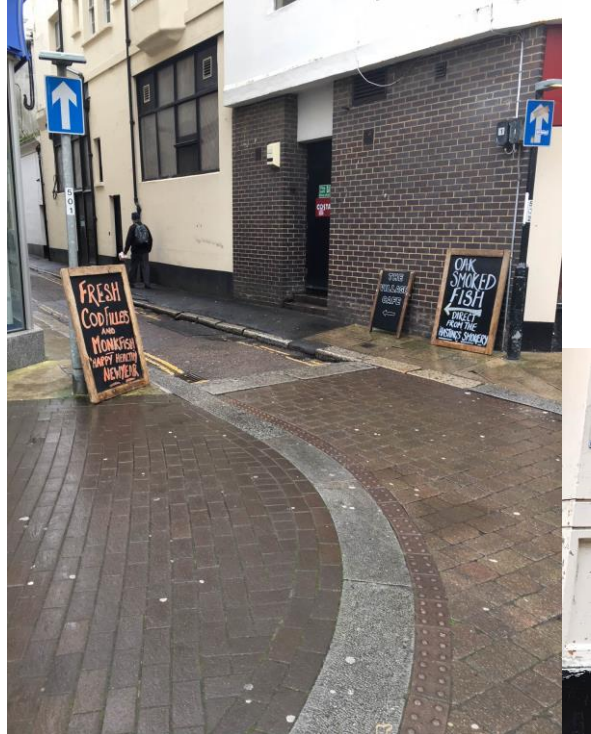
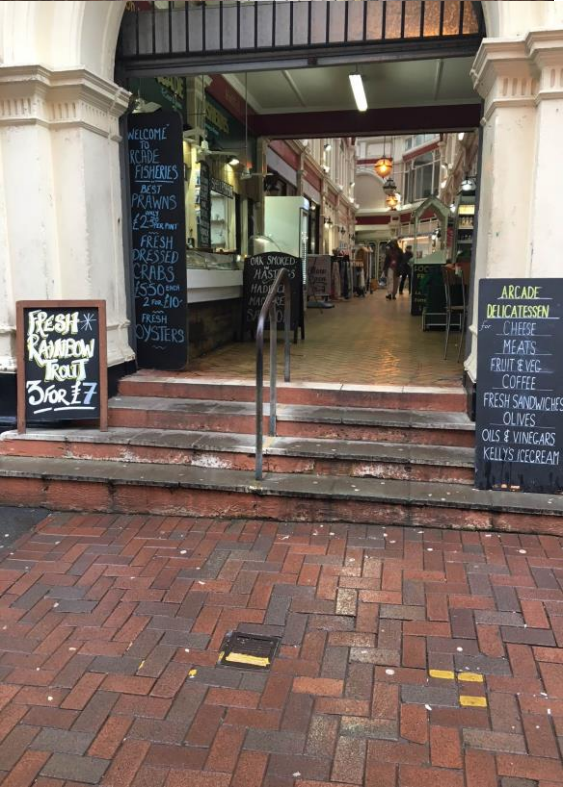
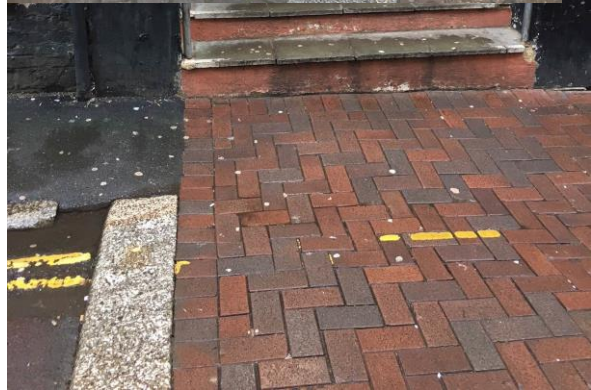
Appendix 1

2.1 Following the presentation of the Petition, a further site visit was conducted on 11 January 2018 and a number of photographs of the condition of the road append this report in Appendix 1.

2.4 The carriageway is in reasonable structural condition with no obvious signs of significant failure such as deformation or large scale crazing and there are no outstanding safety defects. However, the road surface itself is well worn, uneven in places and is nearing the end of its serviceable life.

2.5 The footways are also in reasonable structural condition with no safety defects observed that required immediate attention. However, the surface is uneven in places mainly due to the movement, loss or replacement of adjacent kerbing that is probably due to vehicle overrun. The kerbing along this road consists of a mixture of modern concrete kerbs and narrow and wide granite kerb stones with a number having been replaced with a tarmac fillet at some time in the past.

2.6 There are currently four older-style high pressure sodium floodlights in York Gardens mounted on adjacent buildings, which contrasts with the majority of street lighting in Hastings which has been converted to modern LED type which provides a whiter ('brighter') light and consumes less energy.

2.9 From our records and inspections, both the carriageway and footways in York Gardens are categorised as being in poor condition.

3.2 Work to resurface the road and footways and replace the older granite kerbing with a more consistent modern kerbing would reduce future maintenance liabilities and, combined with an upgrade of the street lighting to modern LED lighting, would provide an improved route for pedestrians.

3.5 Lead Member is recommended to advise the Petitioner that we are aware of the condition of York Gardens and do have plans to resurface the carriageway, footways, replace the kerbing where appropriate and upgrade the street lighting as part of the future capital works programme.
